FJ-3 "Fury"

FJ-3, F-1C

This report summarizes the activities, findings, and recommendations of a special committee charged with investigating the accident of the XP6M-1 SeaMaster on December 7, 1955.

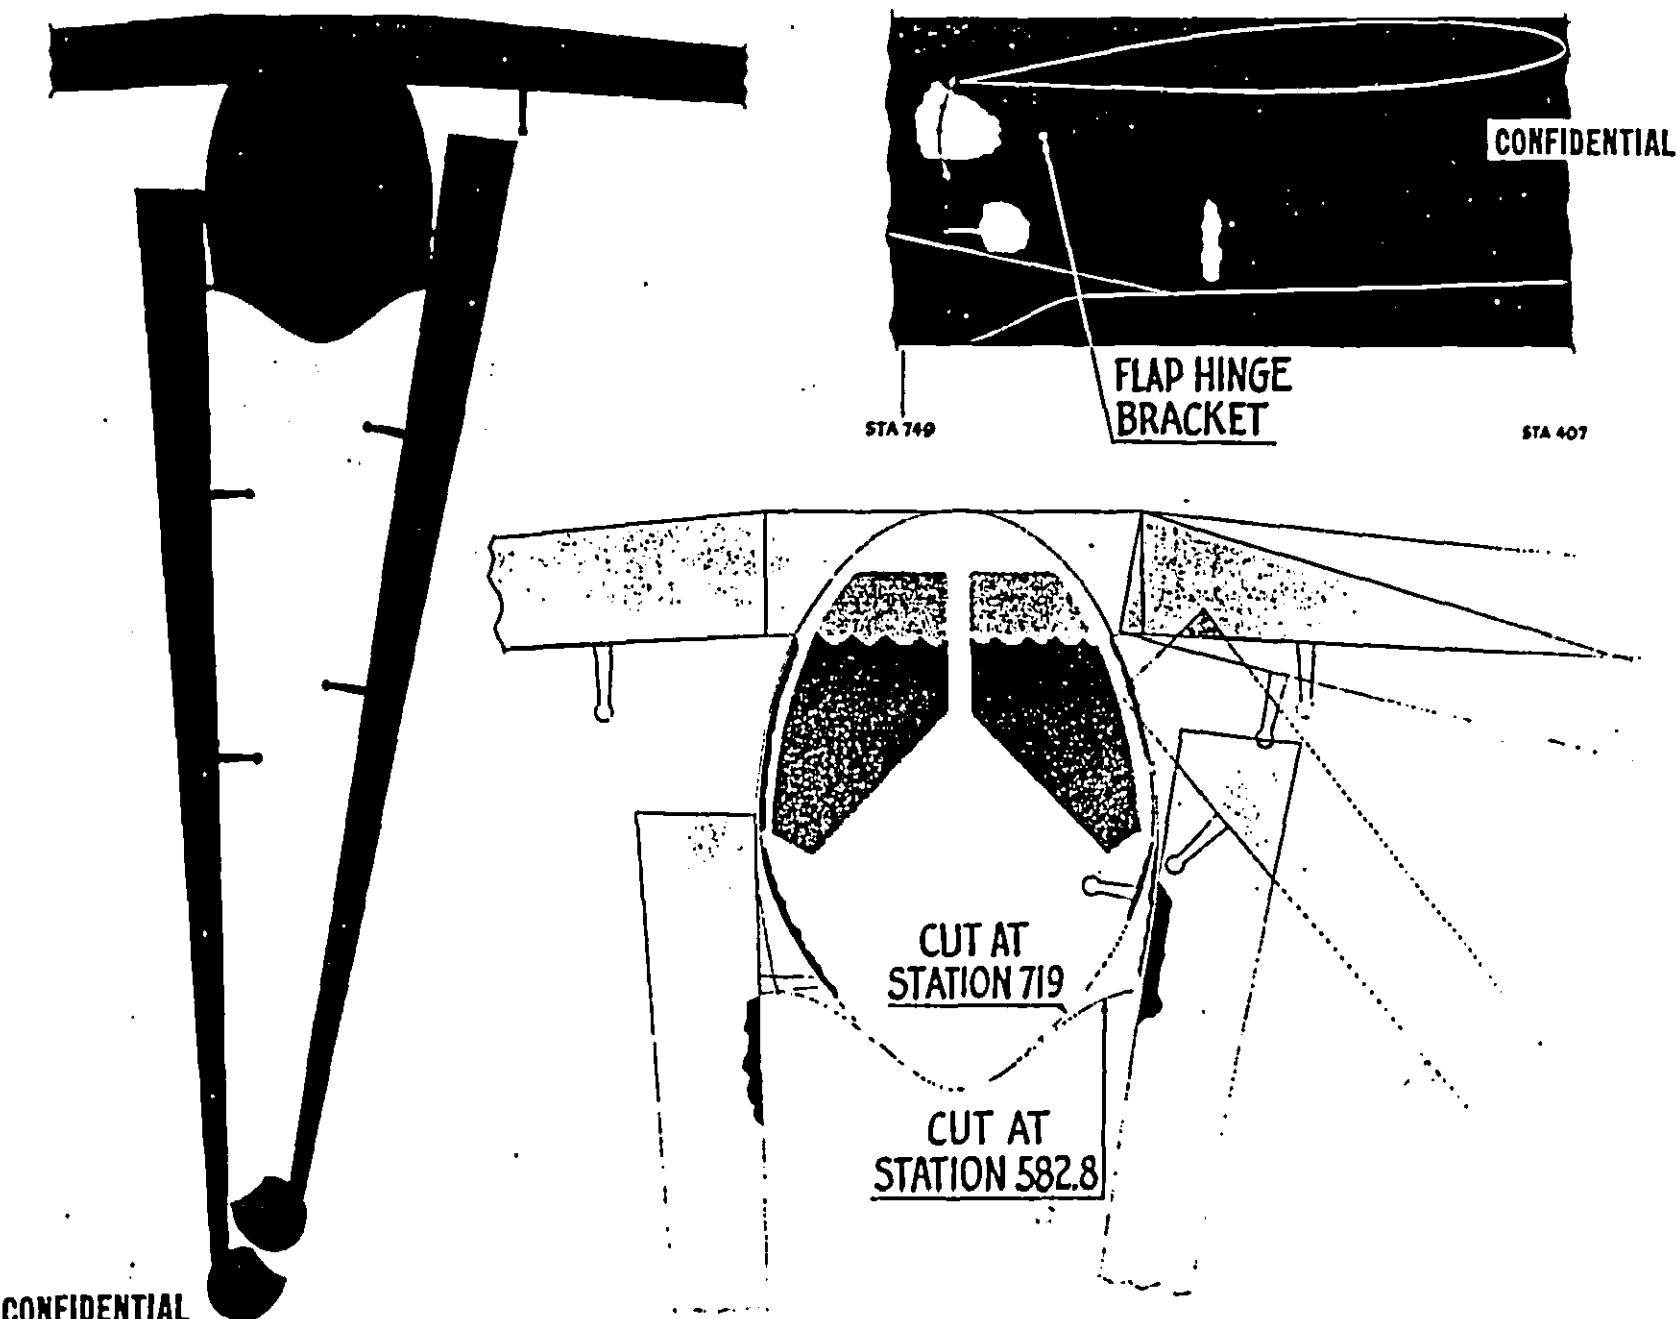
Fig. 11. Wing Failure

- 5) The primary structural failure of the wings occurred in negative bending after a severe nose-down pitch of the aircraft.
- 6) The stabilizer appears to have failed after the initial wing failure.

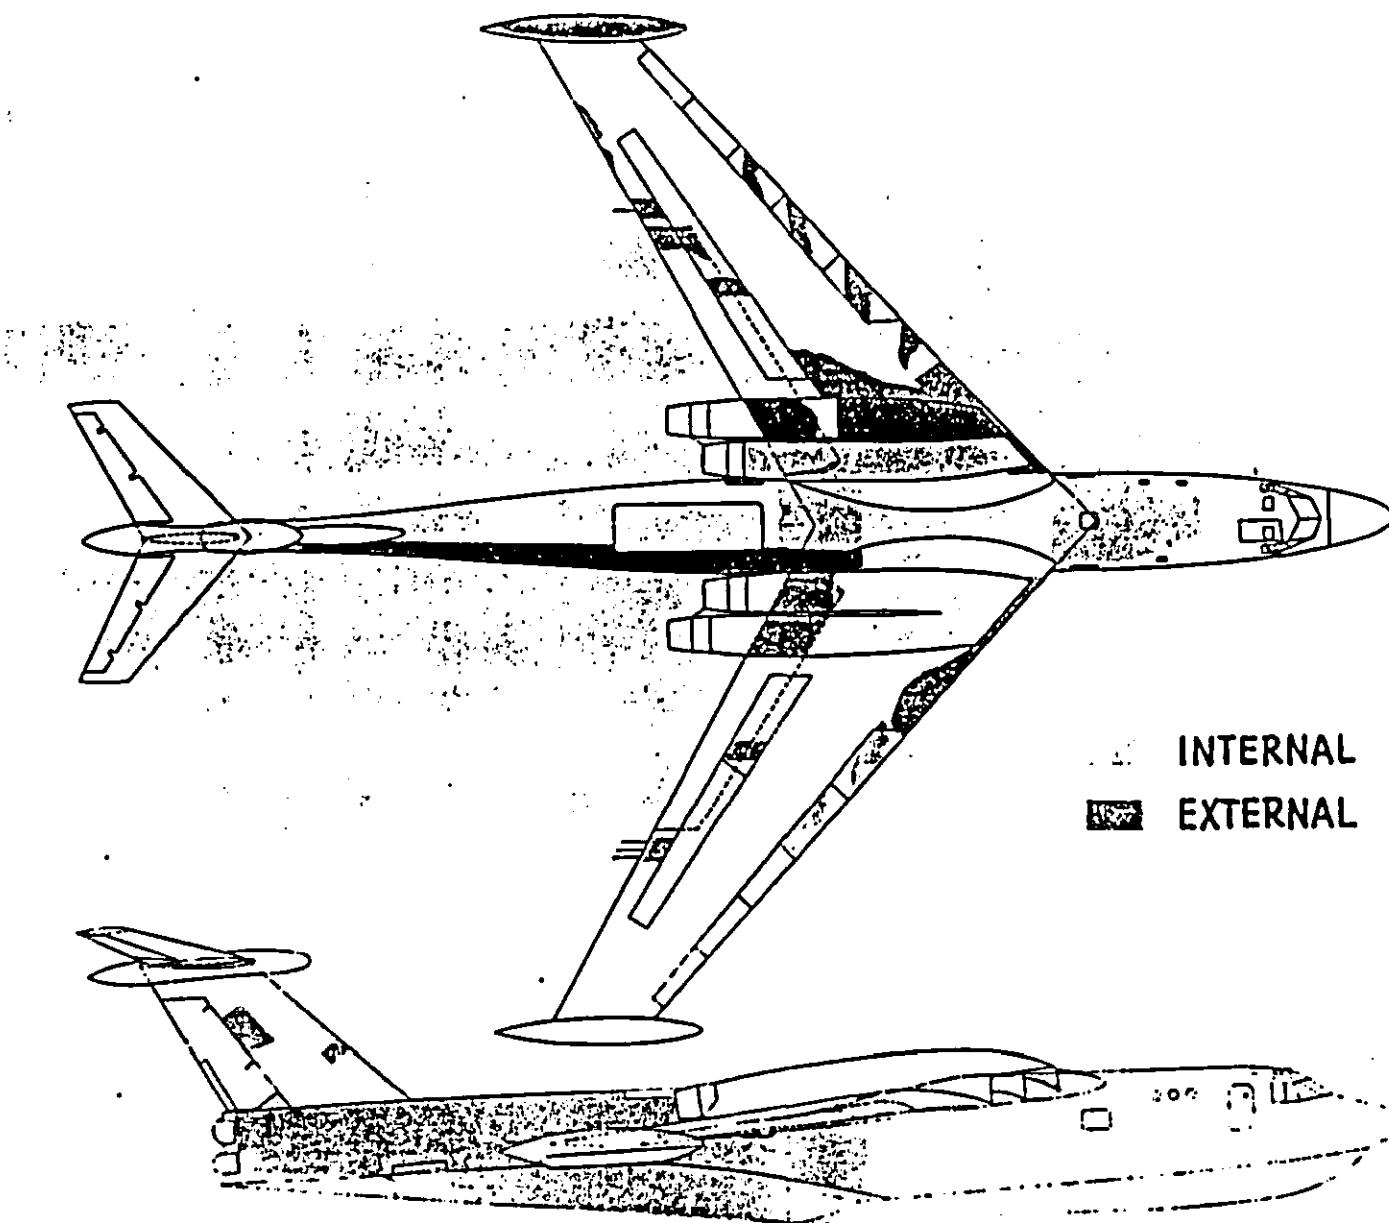
Fig. 15. Fire Pattern

- 7) Most of the fires and explosions reported by witnesses and found as evidence on the wreckage occurred after structural break-up. A limited fire or explosion could have existed before break-up.

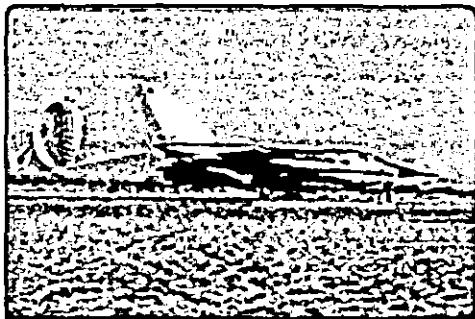
Maj. "Fitz" Fulton landed the crippled B-58 on a heavily torched runway.

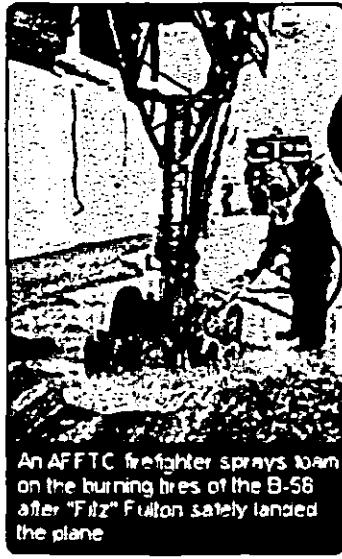
An AFFTC firefighter sprays foam on the burning tires of the B-58 after "Filz" Fulton safely landed the plane
