National Transportation Safety Board
Washington, DC 20594

Brief of Accident

LAX04FA057
File No. 18490 12/4/2003 Rosamond, CA Aircraft Reg No. N8602J Time (Local): 08:54 PST

Make/Model: Wing Aircraft / D-1
Engine Make/Model: Lycoming / IO-320-B1C
Aircraft Damage: Destroyed
Number of Engines: 2
Operating Certificate(s): None
Type of Flight Operation: Instructional
Reg. Flight Conducted Under: Part 91: General Aviation

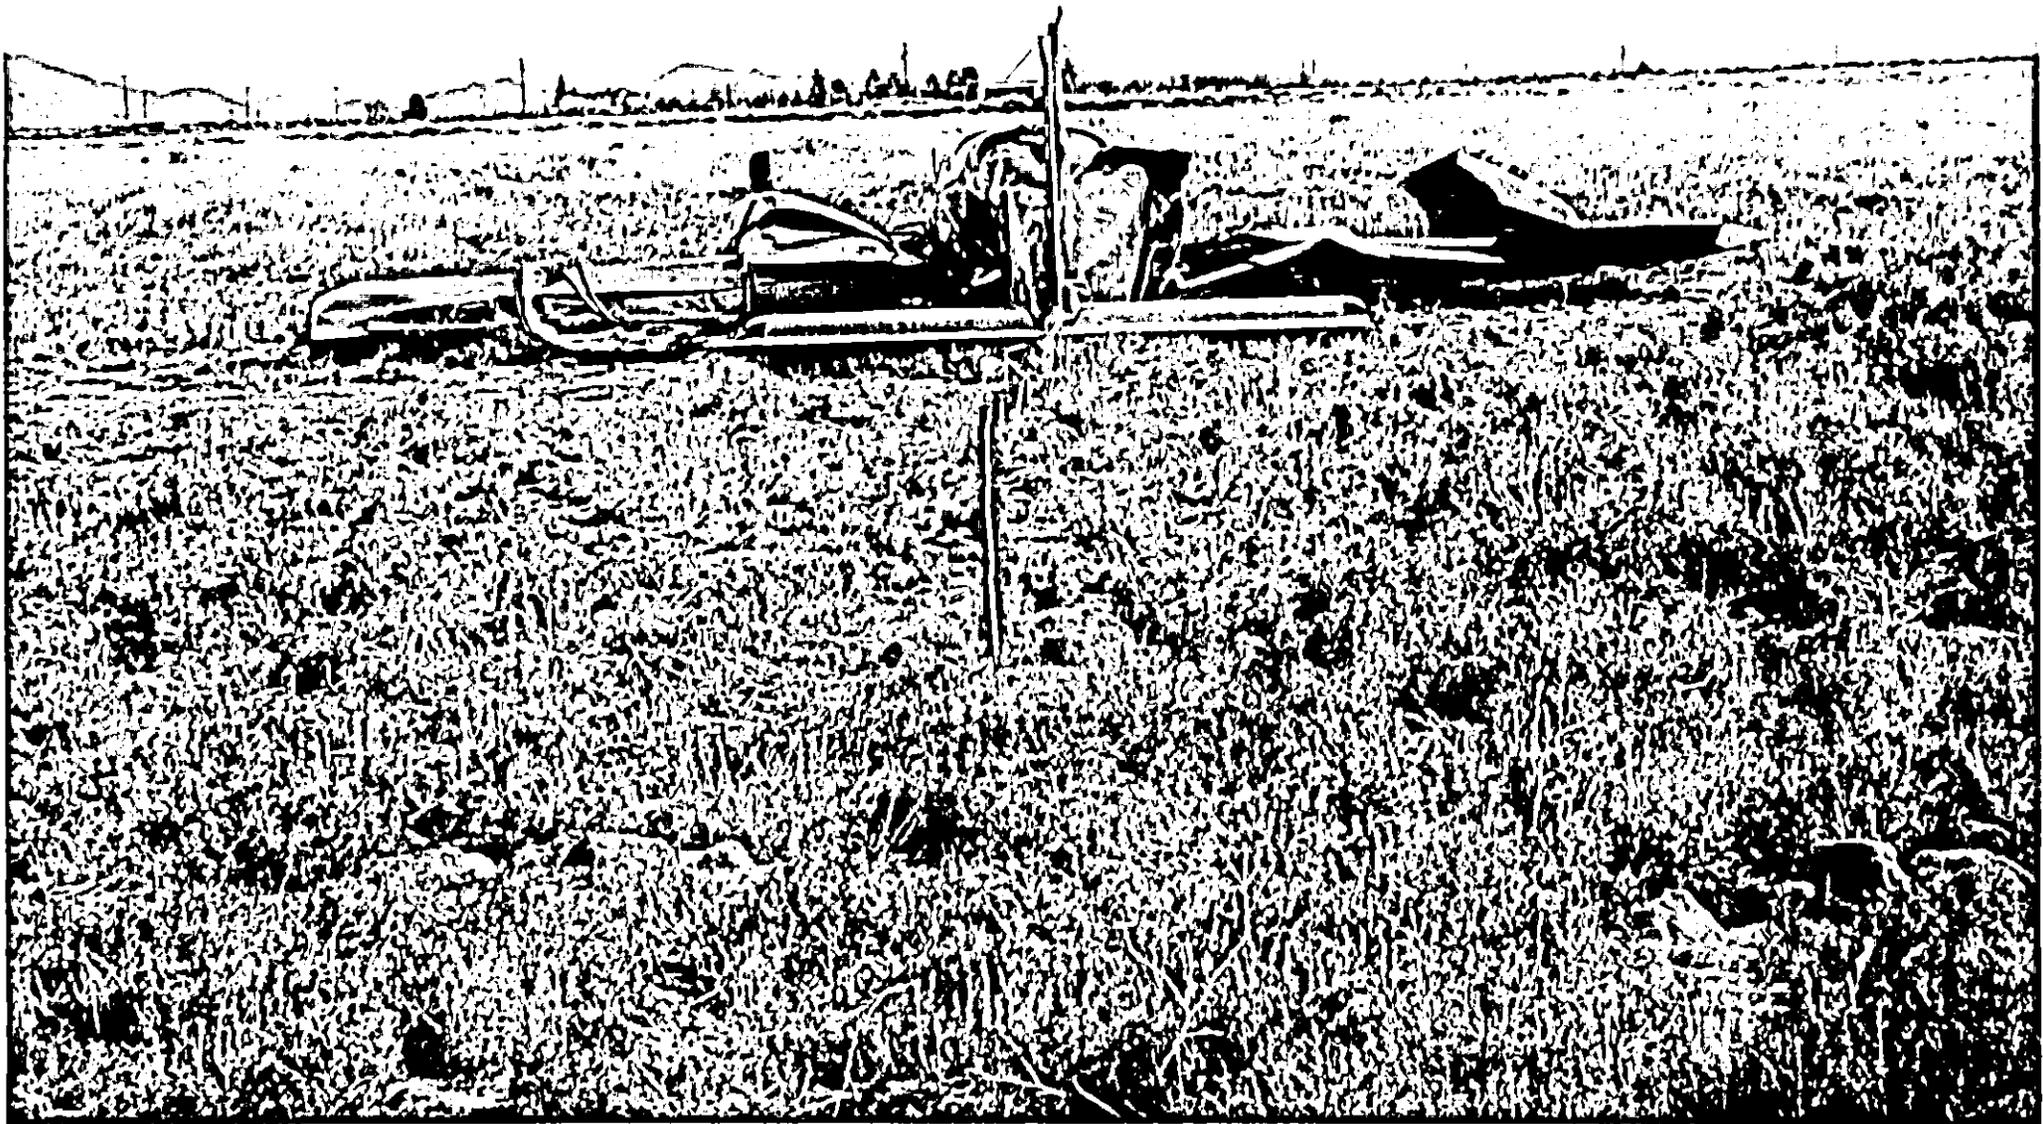
Photo 1 - Act all view

The Safety Board IIC, an FAA inspector, a Lycoming representative, and a representative from Flight Research, Inc., examined the wreckage at the accident scene on December 5, 2003. The airplane impacted level desert 2,600-foot mean sea level (msl) terrain less than 1/4-mile from the last location at which it was observed on radar. The wreckage was found at the following approximate global positioning satellite coordinates: 34 degrees 50.682 minutes north latitude by 118 degrees 23.299 minutes west longitude. A circular area around the airplane was devoid of vegetation. The wreckage was distributed in an area approximately 65 feet wide and 122 feet long. The nose of the airplane came to rest facing a

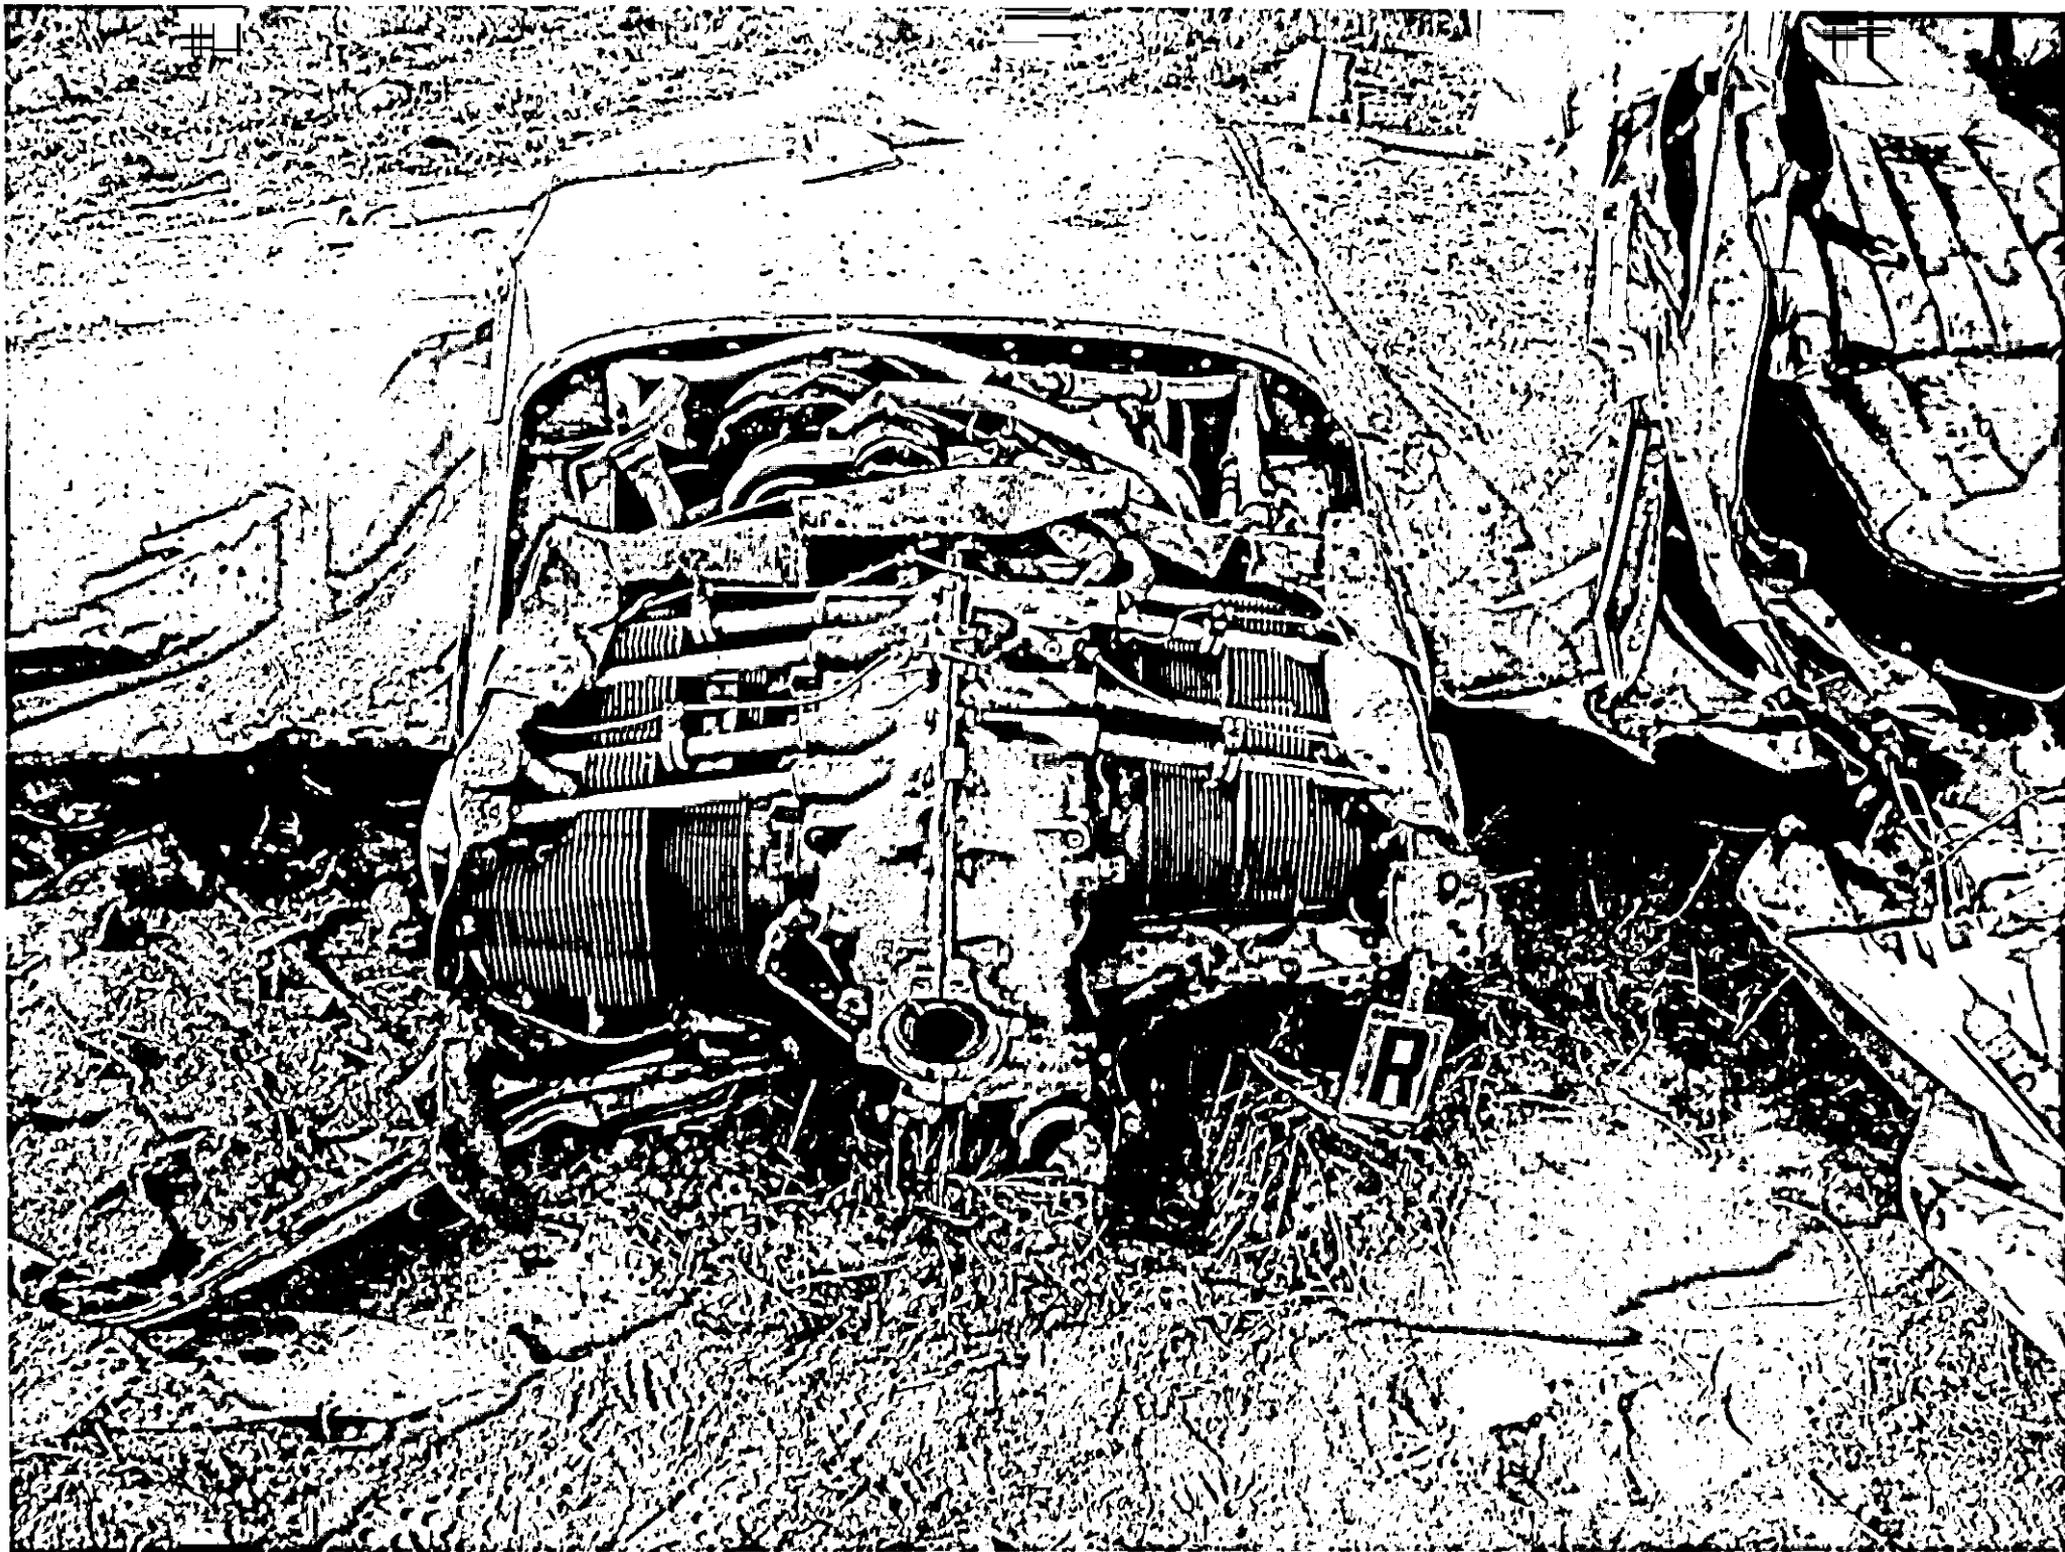
Photo 9 - Right engine

The right engine crankshaft was rotated. Fuel was present throughout the system. The flow divider was examined, the gaskets were intact, and no perforations or holes were found. The top spark plug electrodes were dark and sooty, which corresponded to rich operation according to the Champion Aviation Check-A-Plug AV-27 Chart. The bottom spark plugs, excluding cylinder number 4 (which could not be removed), were white in color, which corresponded to lean operation according to the Champion Aviation Check-A-Plug AV-27 Chart. The number 3 and number 4 cylinders were borescoped. Their coloration was consistent with normal

operation. The right propeller hub was found detached and forward of the right engine. Blade 1 did not display any torsional deformation. Chordwise striations were found on both the cambered and face side. There was no evidence of leading edge gouging. Blade 2 was undamaged.

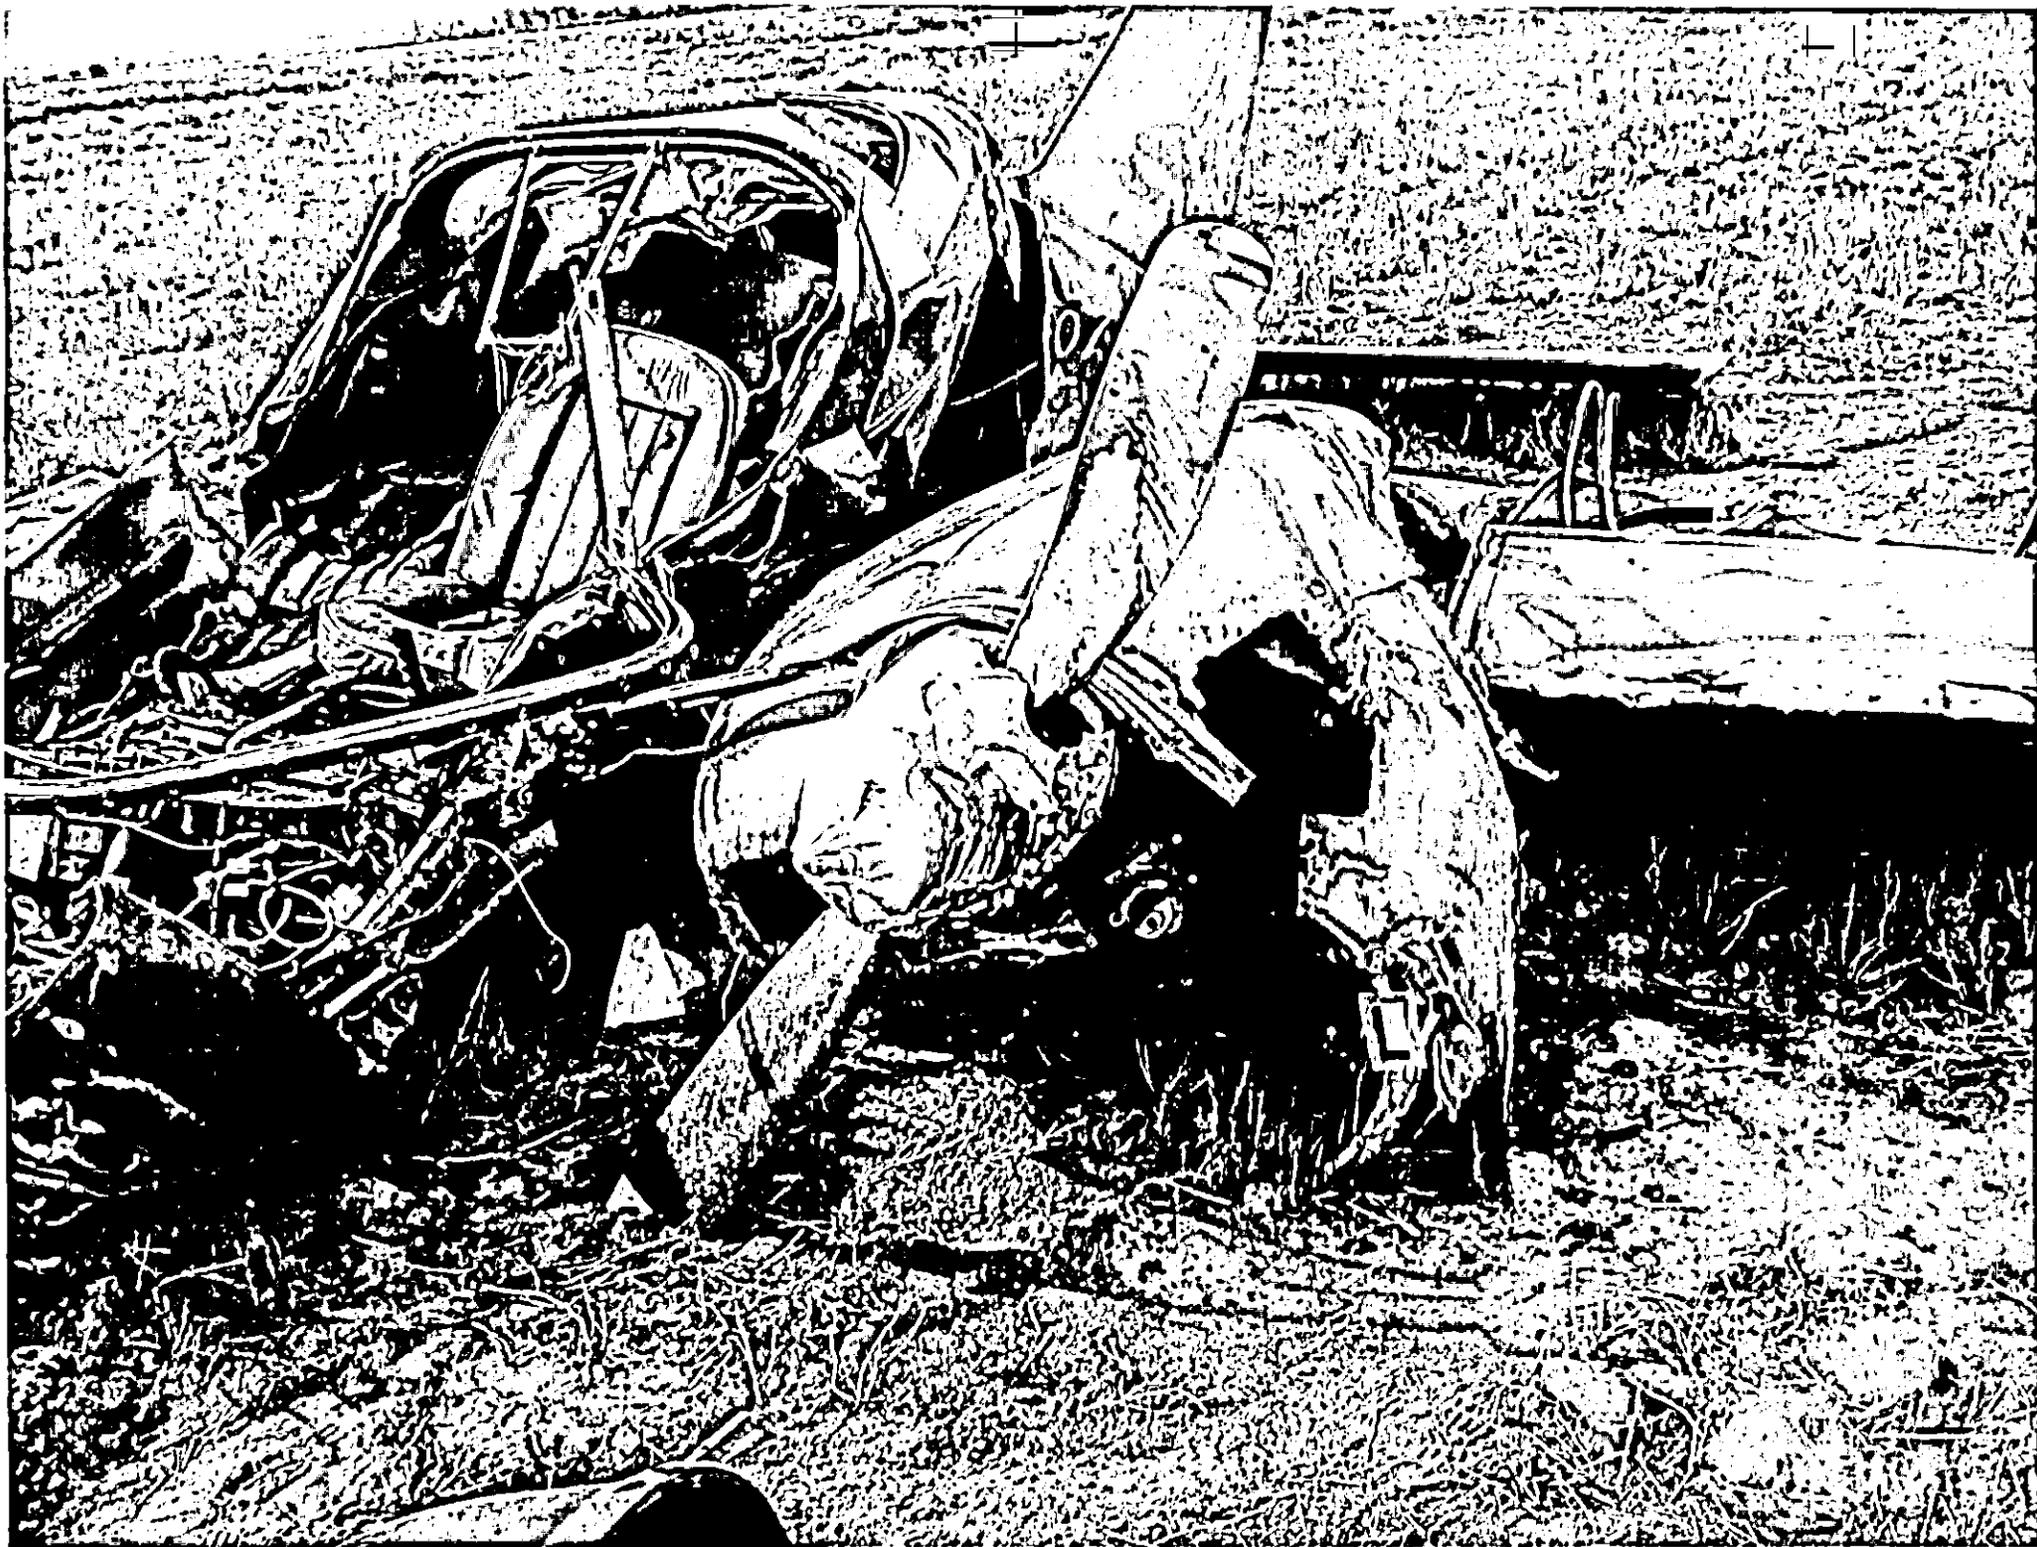
Photo 10 - Left engine & prop

The engines and propellers were examined. The left engine crankshaft was rotated. Fuel was present throughout the system. The flow divider was examined, the gaskets were intact, and no perforations or holes were found. The spark plug electrodes were gray in color, which corresponded to normal operation according to the Champion Aviation Check-A-Plug AV-27 Chart. The left propeller remained attached to the left engine. Blade 1 was undamaged. Blade 2 was bent slightly aft. Chordwise striations were found on the cambered surface, and none were found on the face. There was no evidence of leading edge gouging.

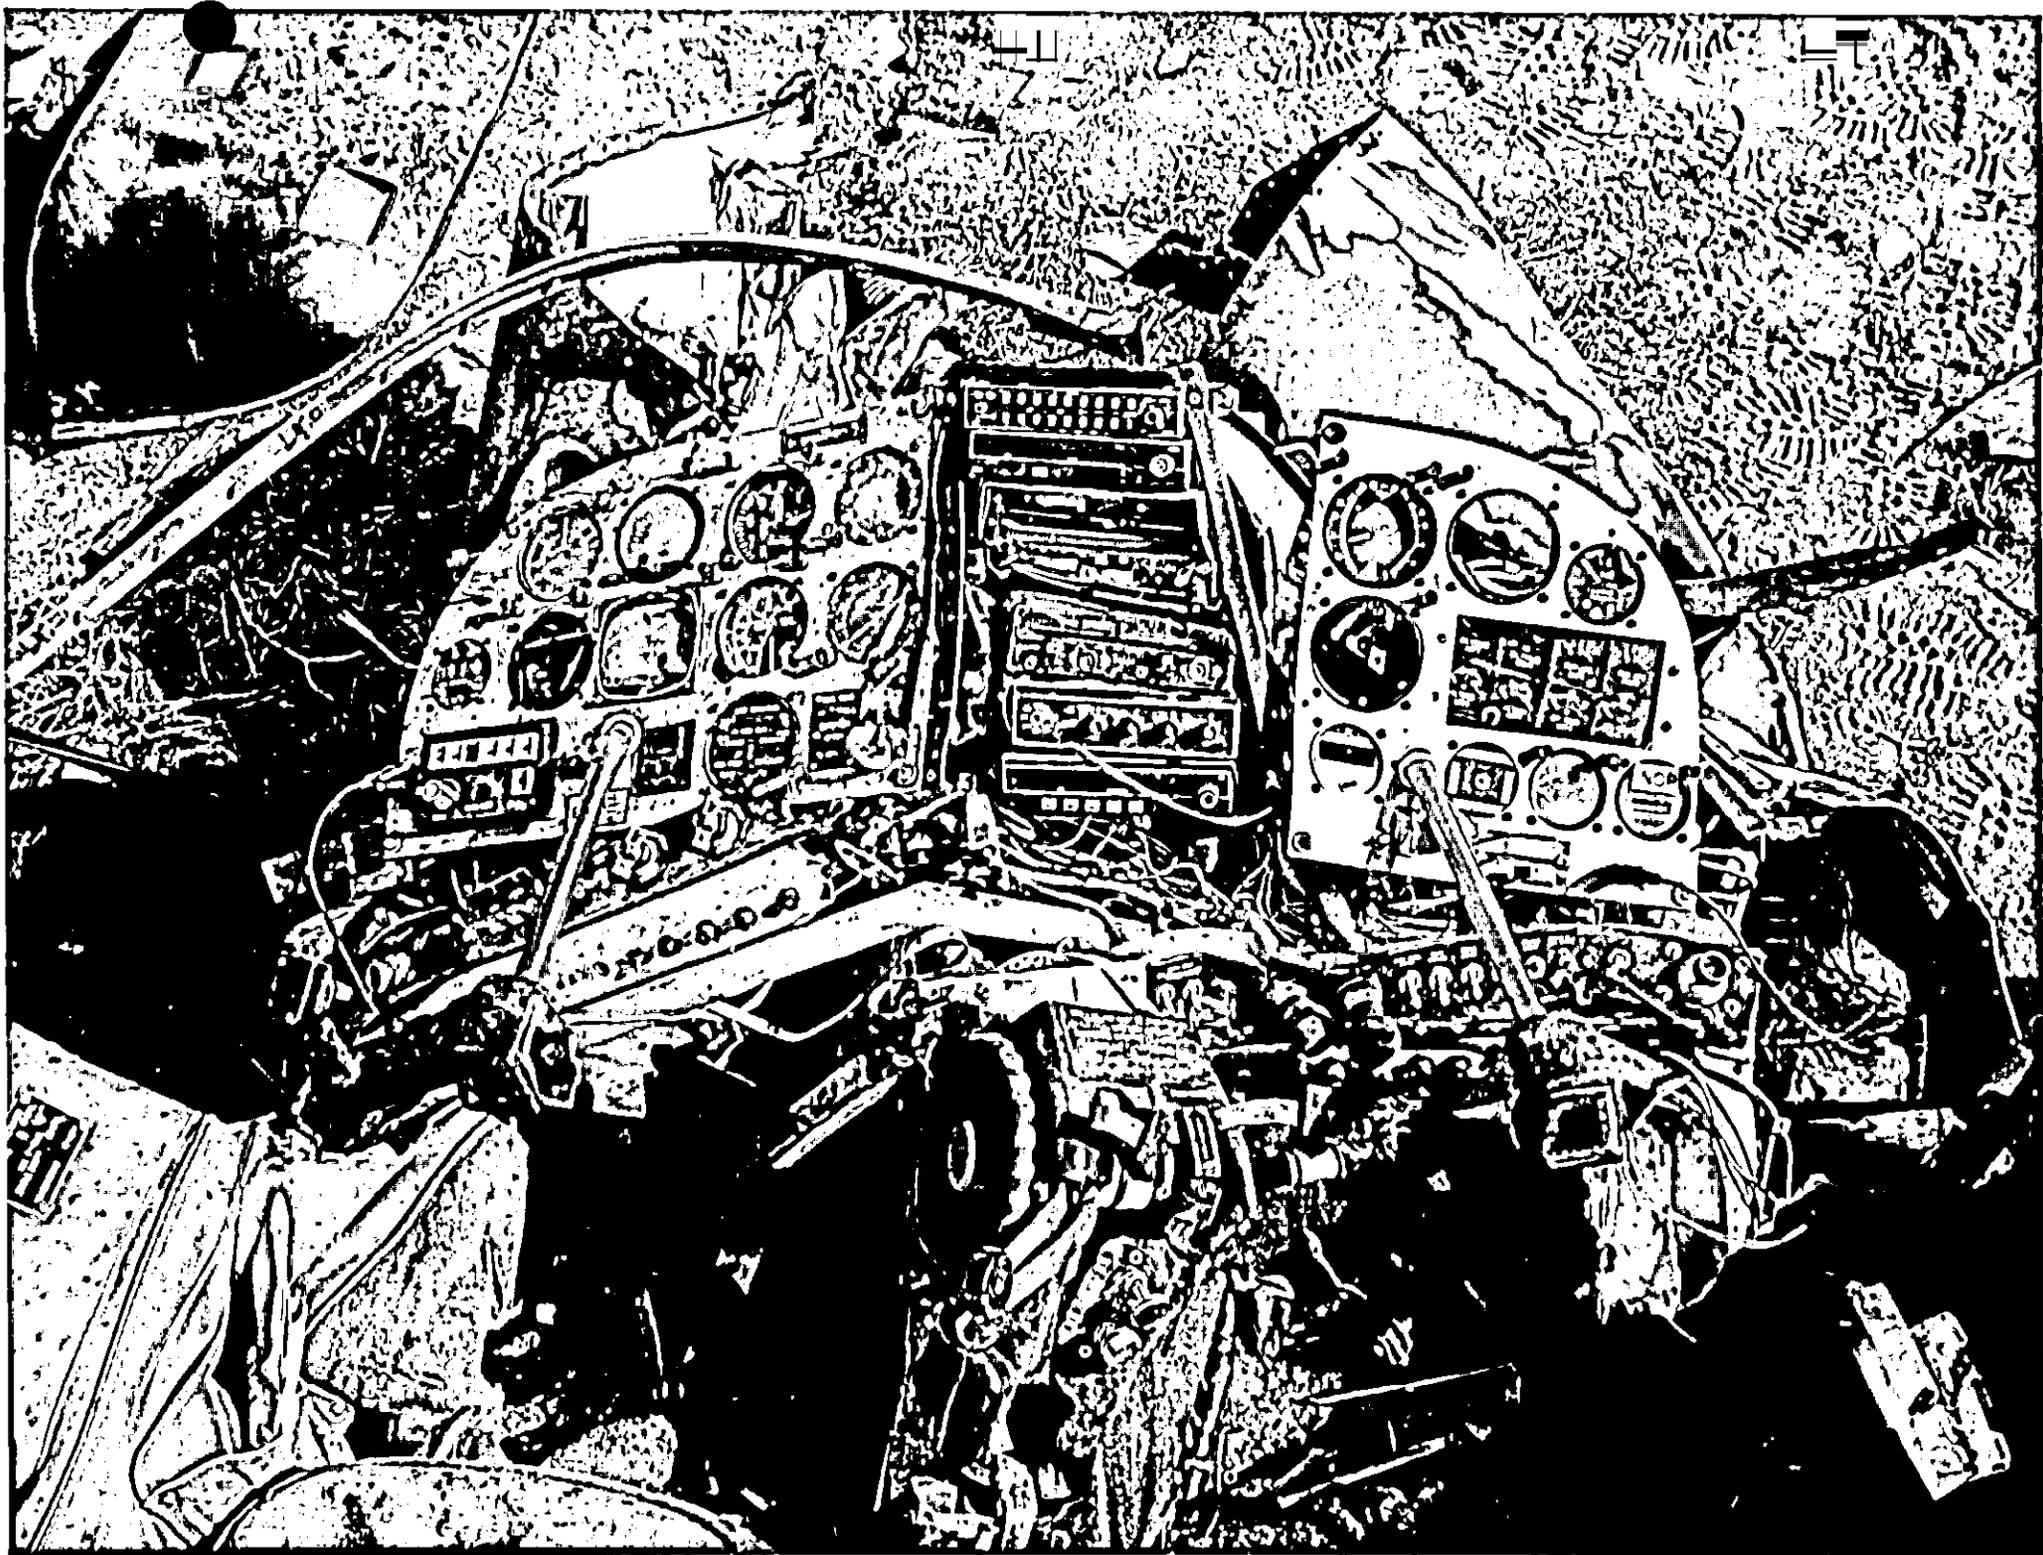
Photo 12 - Cockpit

The cockpit area was examined. The mixture controls were found in the full-forward position. The propeller controls were in the full-forward position and curled right. The throttle controls were in the aft position. The left and right magnetos' switches were in the both position and clicked when turned to the off position. The landing gear selector was in the down position and displaced slightly right. Both control yokes were in the full aft position and bent downward. The left yoke vertical grip on the right side was not attached. Neither of the right yoke vertical grips were attached.

The airplane was recovered from the accident scene and was reexamined on December 8, 2003. The upper right leg of the cockpit's flight control Y was observed bent and broken. The vertical portion of the control Y exhibited a bending break consistent with an over-travel in the direction it was observed bent.

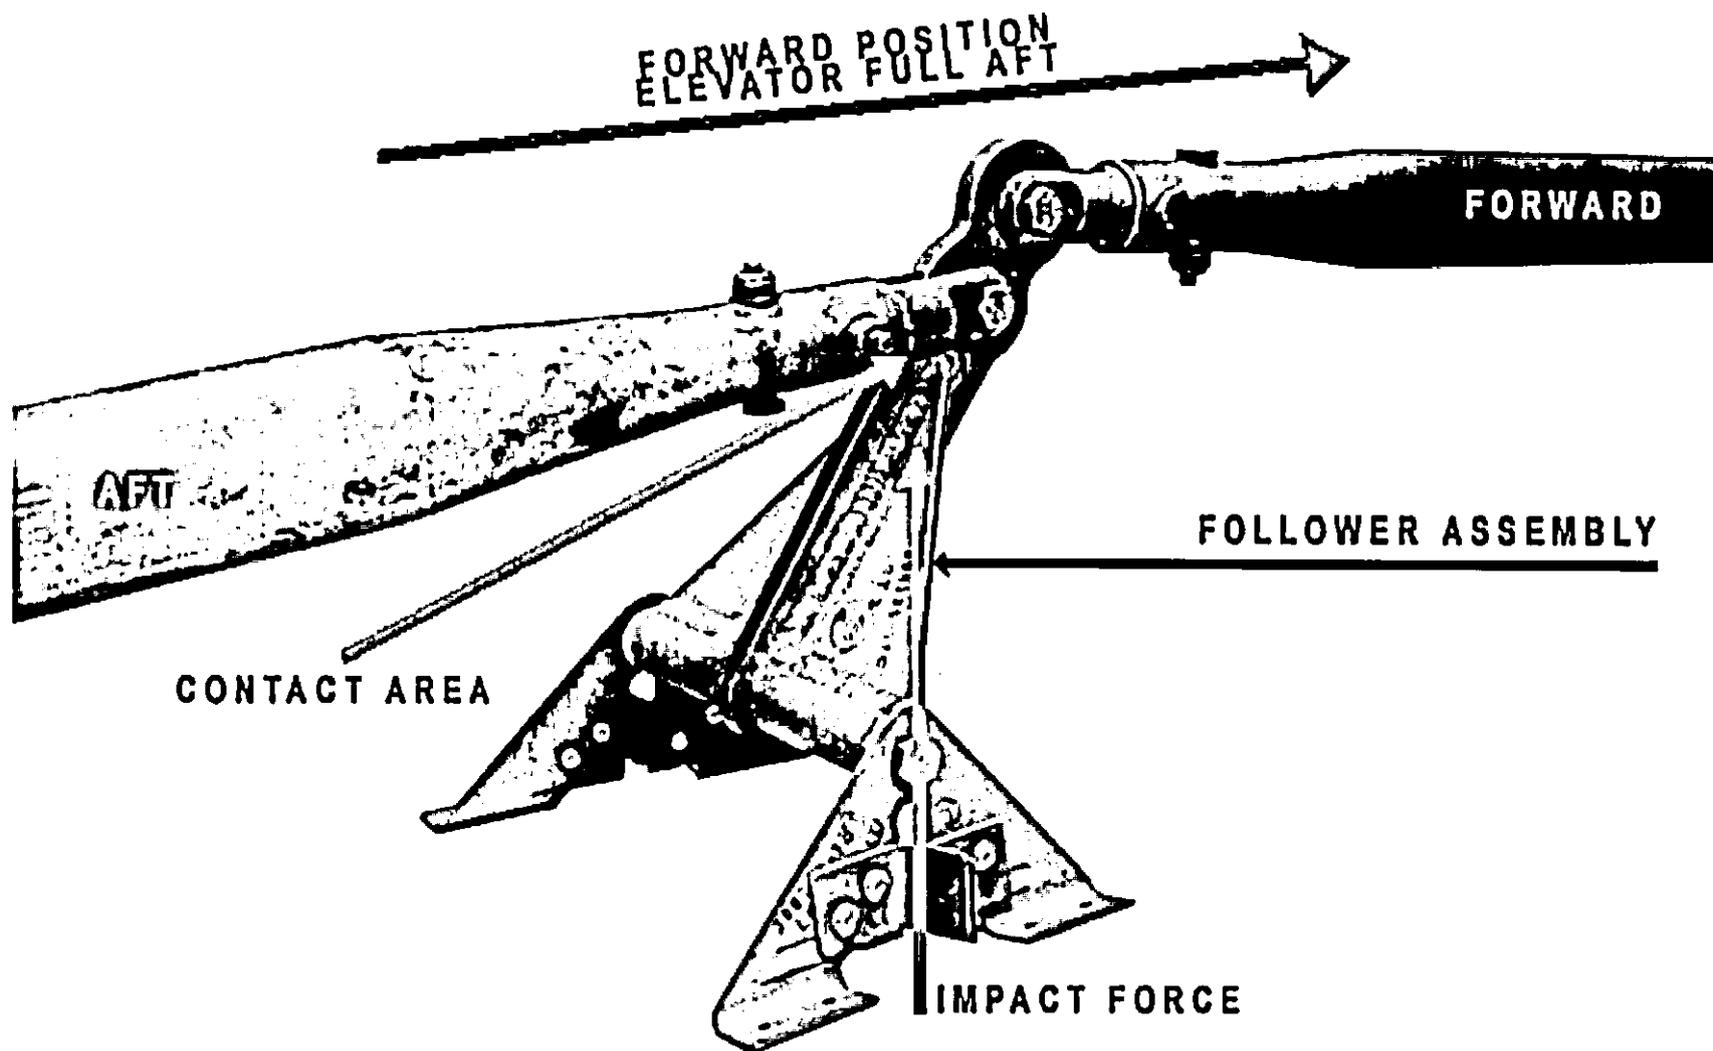
Photo 1. Elevator Control (1)

The elevator was controlled through a series of push-pull tubes. The rear push-pull tube was found separated at the belly mounted pivot follower. A 3-inch end section that attached the rear push-pull tube to the follower was not recovered. The attachment to the follower displayed a smeared surface on one side; the other displayed a grainy appearance, broken at a 45-degree angle. A bolt attachment to the forward follower was sheared. The control tube was bowed at the fuel selector location.
