# B737 Left Roll and Dove

ANA

- \* 6 Sep, 2011
- \* NH140 (Operated by Air Nippon)  
B737-700, from Okinawa to Tokyo(Haneda)
- \* FL410 , 23nm south of LHE  
(Hamamatsu)
- \* Cruising at Mach 0.73(ECON 0.77)
- \* VMC, Pitch-dark night

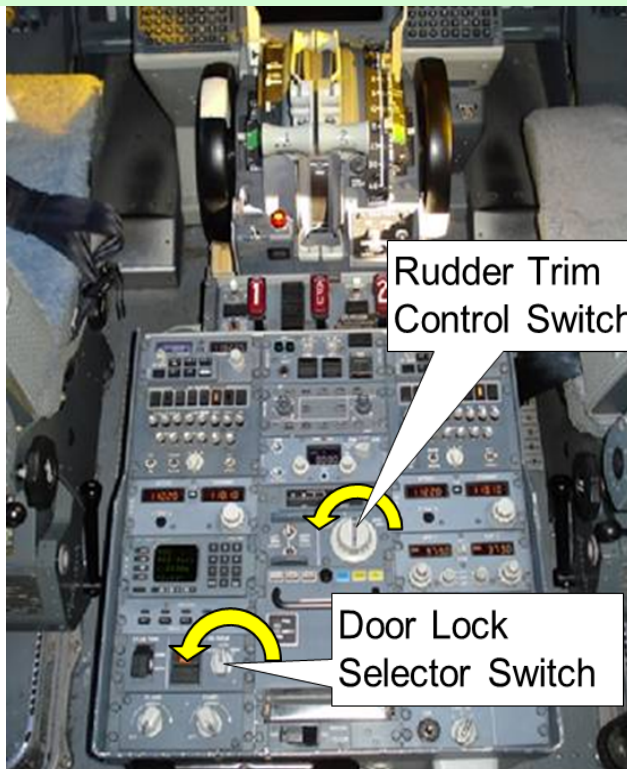
① While the PIC is out of flight deck for rest room, ATC clears NH140 to proceed direct to TATEYAMA. As PF operated CDU, PF heard PIC knocking on the cockpit door at almost same time. PF then quickly executed CDU command key and reached Cockpit door unlock knob without carefully looking the SW itself.

Switch” instead of “Door unlock switch.  
(Duration: left for 6 sec. ⇒ 2 sec. off ⇒ then  
Duration: left for 6 sec. ⇒ 2 sec. off ⇒ then  
again left for 6 sec.)

③ PF became aware that he made a mistake at the end of total 12 sec. rudder trim movement to the left.

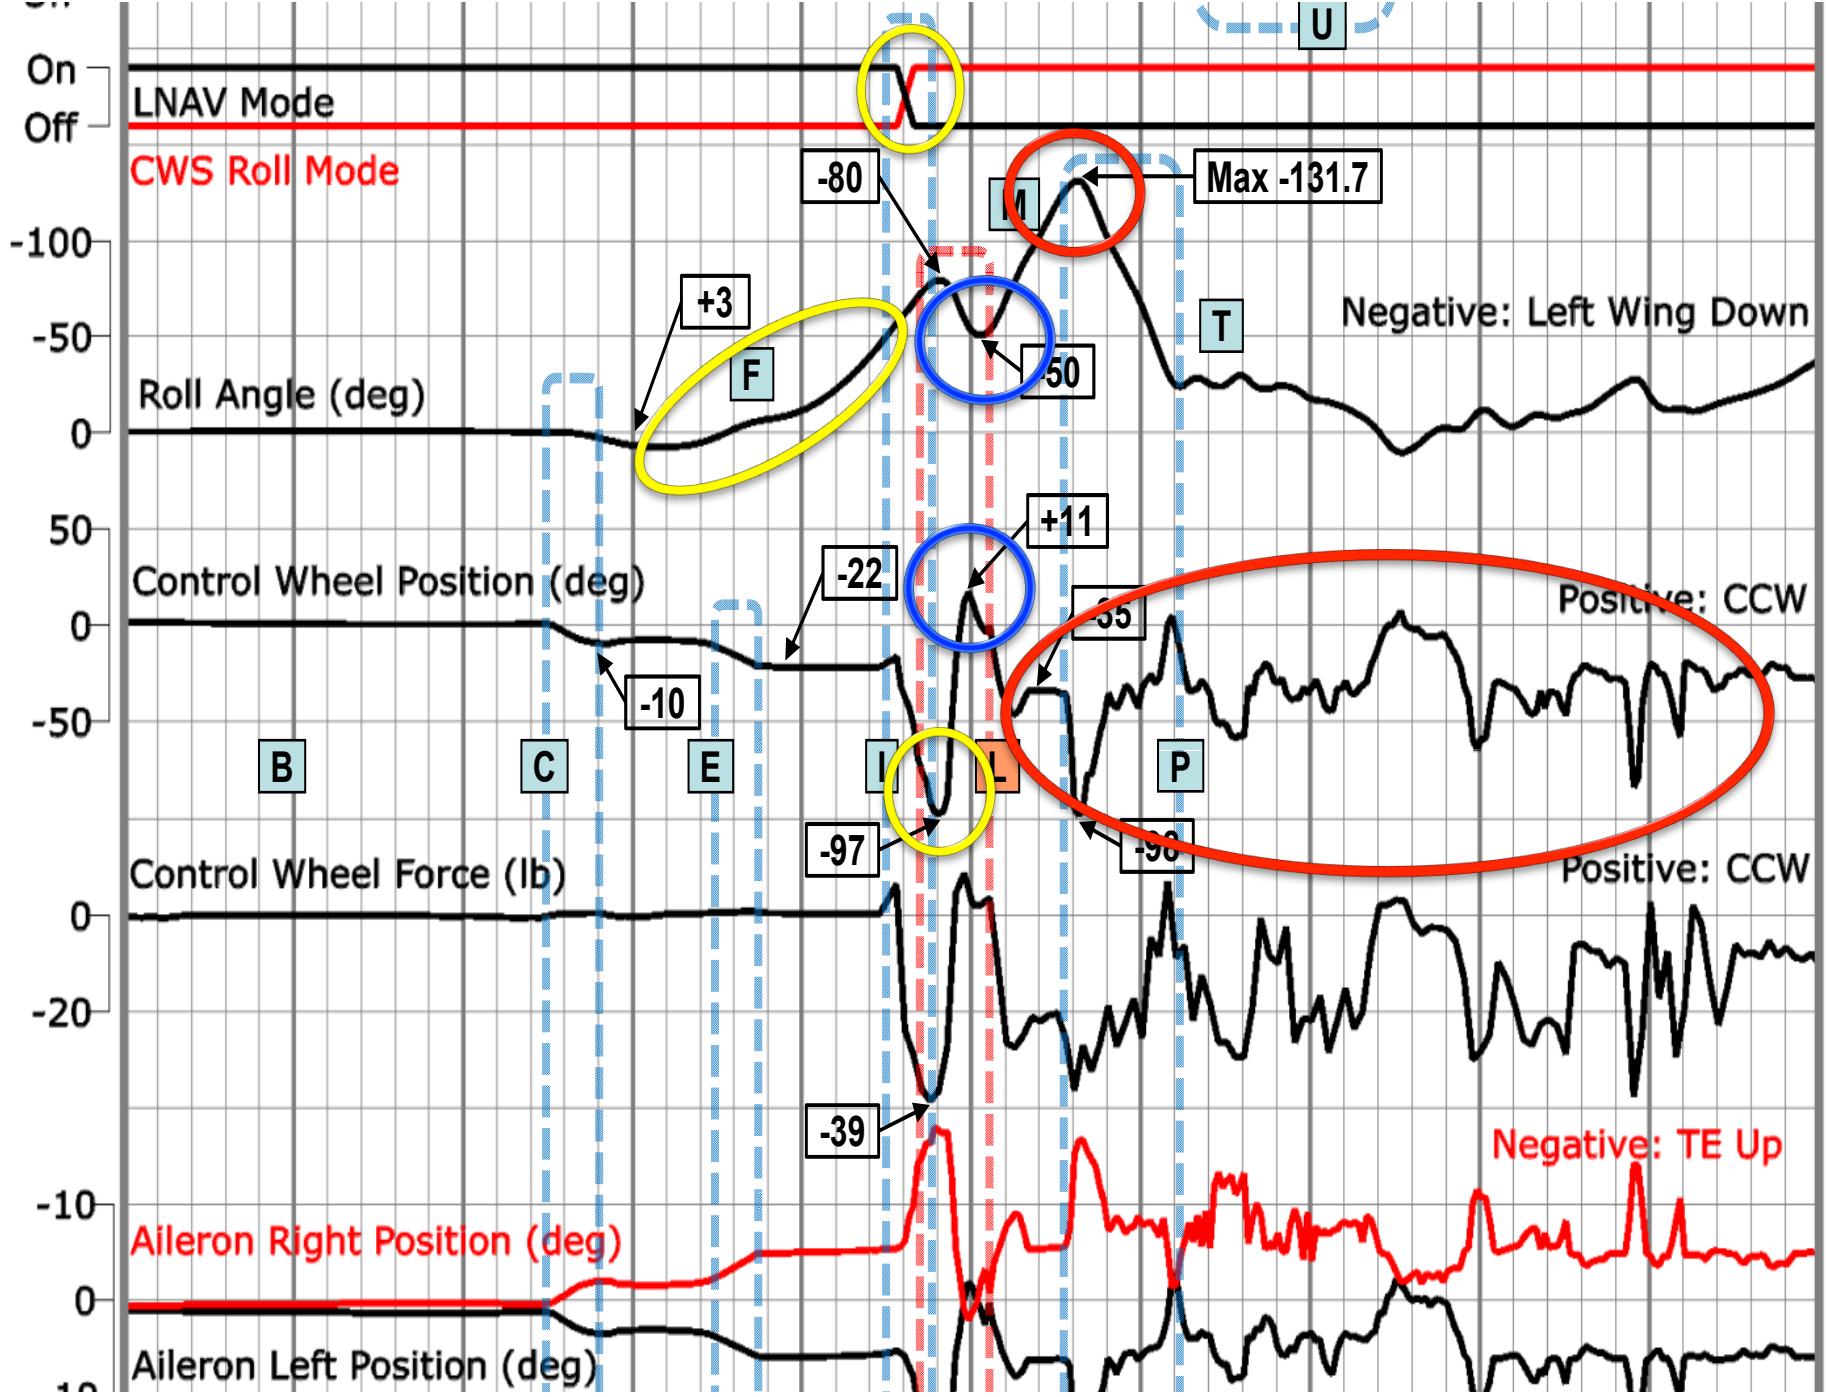
- ① At the point where PF became aware he made a mistake, B737 banked to left exceeding  $35^\circ$  triggering warning sound. PF started recovery maneuver 3 sec. after B737 rolled into  $35^\circ$
- ② When PIC returned cockpit, the aircraft was almost stable condition, and PIC quickly took over and now PIC became PF.
- ③ The rest of the flight was normal and landed at Haneda airport.

(Left)  $\Rightarrow 80^\circ \Rightarrow 50^\circ \Rightarrow 131.7^\circ$

#### ·Heading: $052^\circ \Rightarrow 257^\circ$

(Mmo.82  $\Rightarrow$  **M.828**)

(MAX2.5G  $\Rightarrow$  **2.68G**)

#### <sup>6</sup>·ALT: 41,000Ft $\Rightarrow$ **34,000Ft**

Note; Autopilot became CWS-R/CWS-P because of added force on CW and losing ALT.

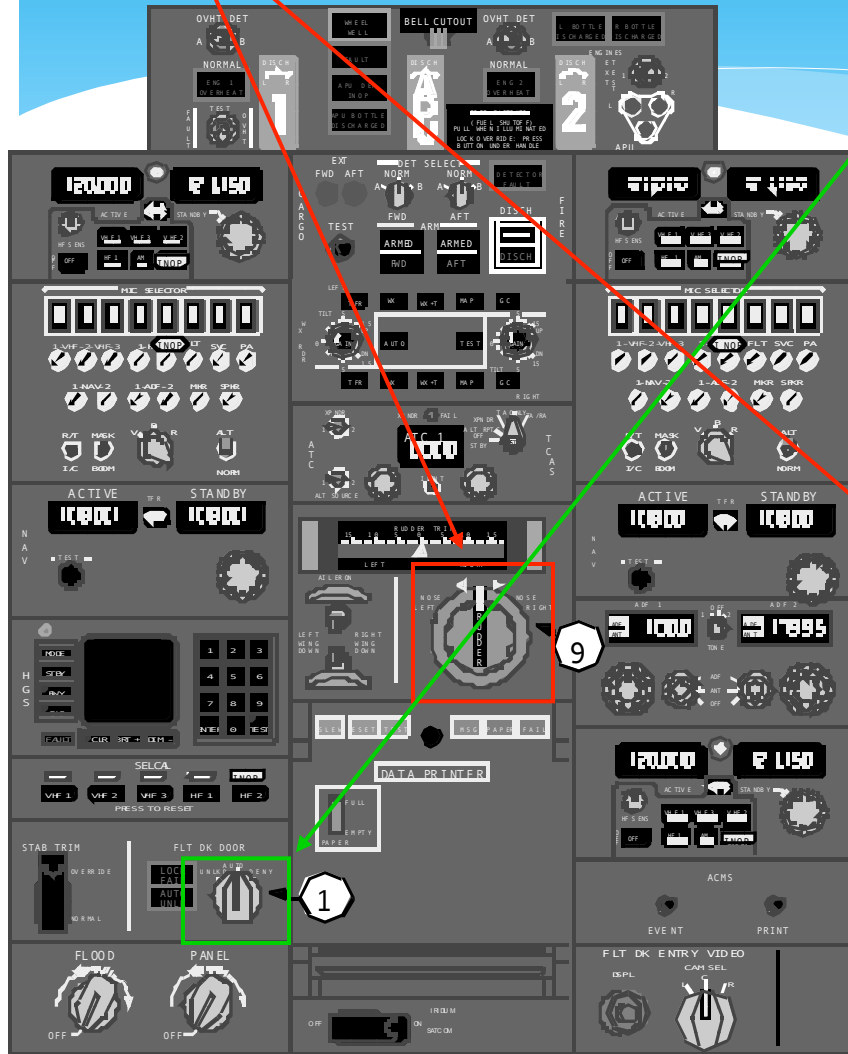
B737-700

It was difficult to feel the differences between the door unlock sw and rudder trim sw during its operation

Rudder Trim Switch

Operation Method  
⇒ Hold and Turn  
Size ⇒ Twice of FLT DK Door Switch

- \* Making educational video material detailed introduction of this event and disseminate it to all flight crew in order to emphasize the importance of operating any switches.
- \* Preparation of Enhanced Stall Recovery training by information collection of how this training is done at other countries.
- \* Is ISARP FLT2.2.17 adequate?

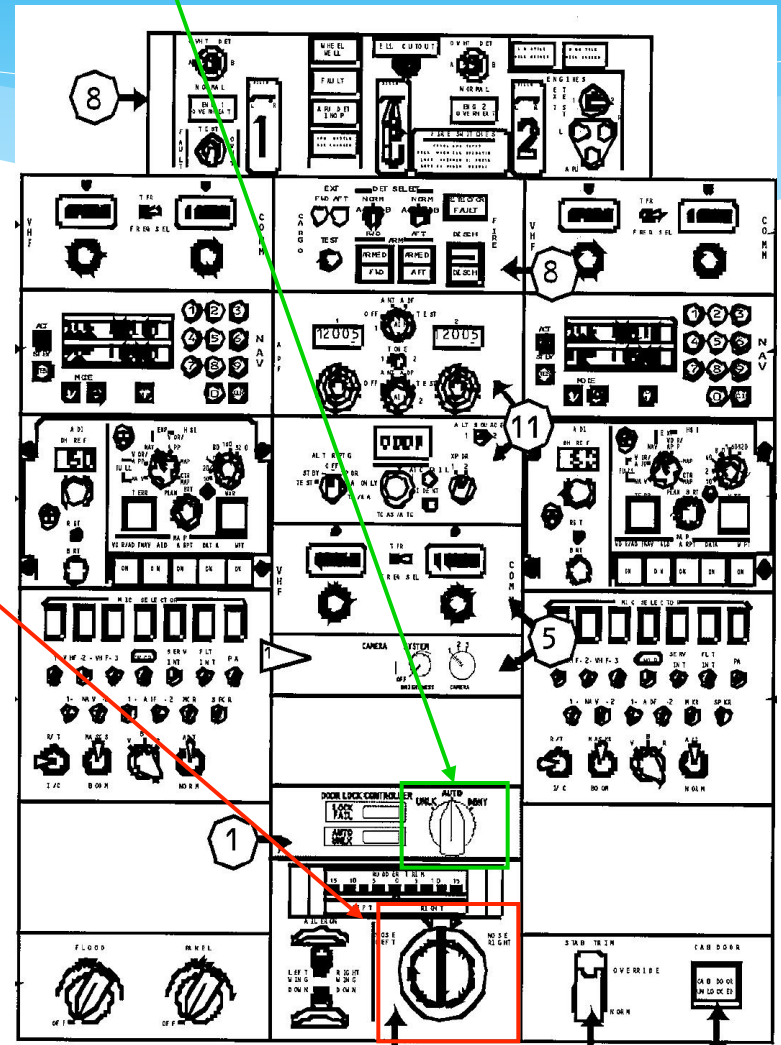
B737-500

FLT DK Door Switch

Operation Method  
⇒ Push & Hold and Turn  
Size ⇒ The half of Rudder Trim SW
