Lessons Learned from a Scan Eagle Inadvertent Departure from Controlled Flight

LCDR Shaun “Linus” Swartz

VX-31 UAS Project Officer

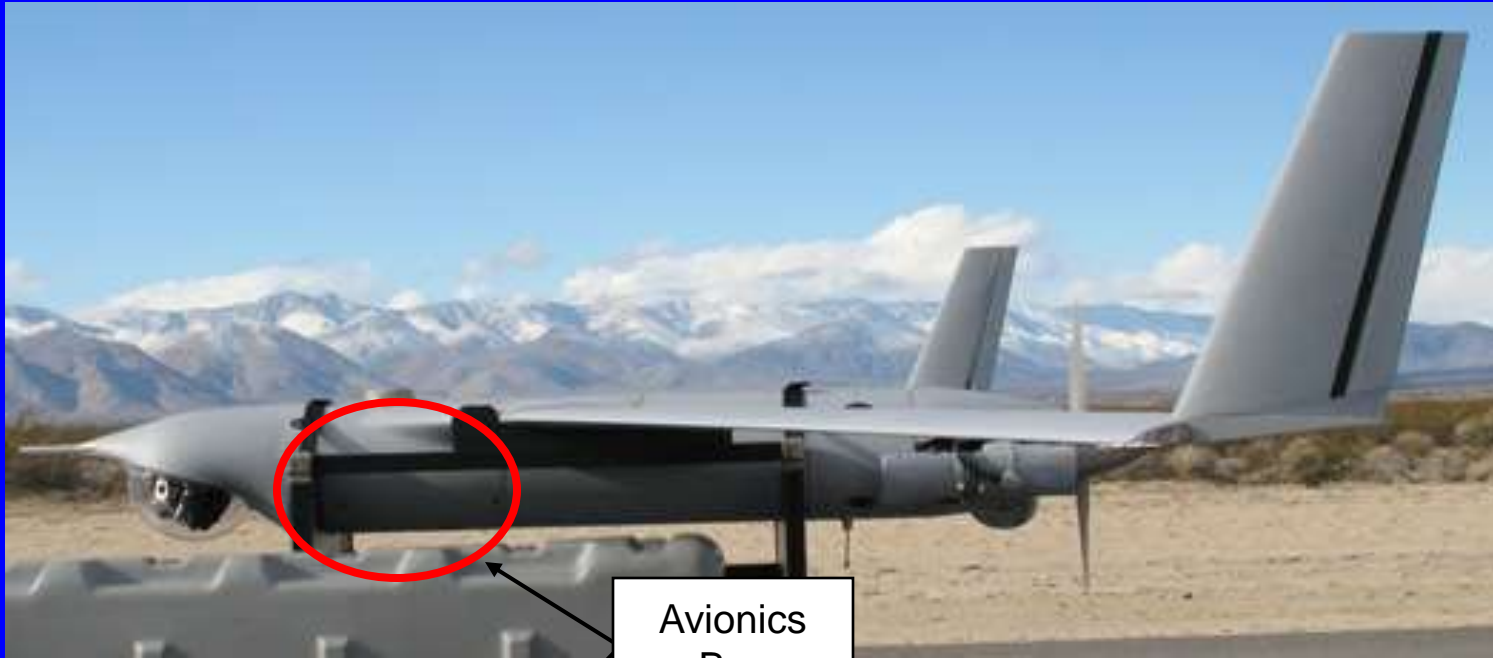
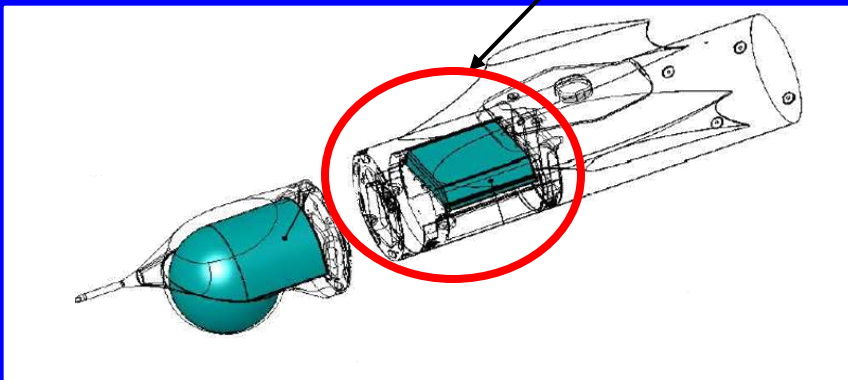
Mishap Payload Configuration

- Payload installed in avionics bay
 - No loss of ISR capability
 - Recommended by Manufacturer*
 - Parts readily available *

*Holes in the “Swiss Cheese”

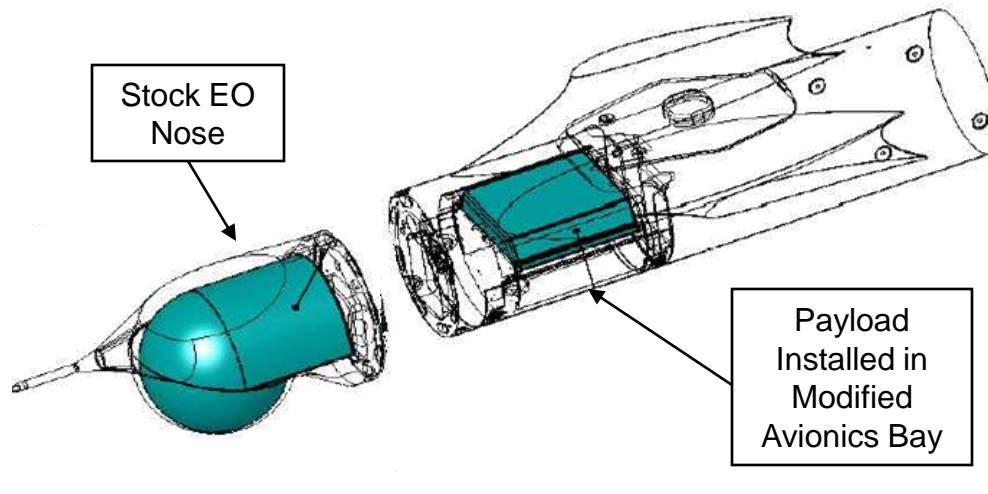
Mishap vs. Final Payload

- A/C loses no ISR capability
- Emitters less than 1/2" from yaw rate gyro
- Many delicate/sensitive parts inside avionics bay

- Emitters 12 times farther away from sensors
- New payload bay is a carbon fiber tube...
