FJ-3 "Fury"

FJ-3, F-1C

This report summarizes the activities, findings, and recommendations of a special committee charged with investigating the accident of the XP6M-1 SeaMaster on December 7, 1955.

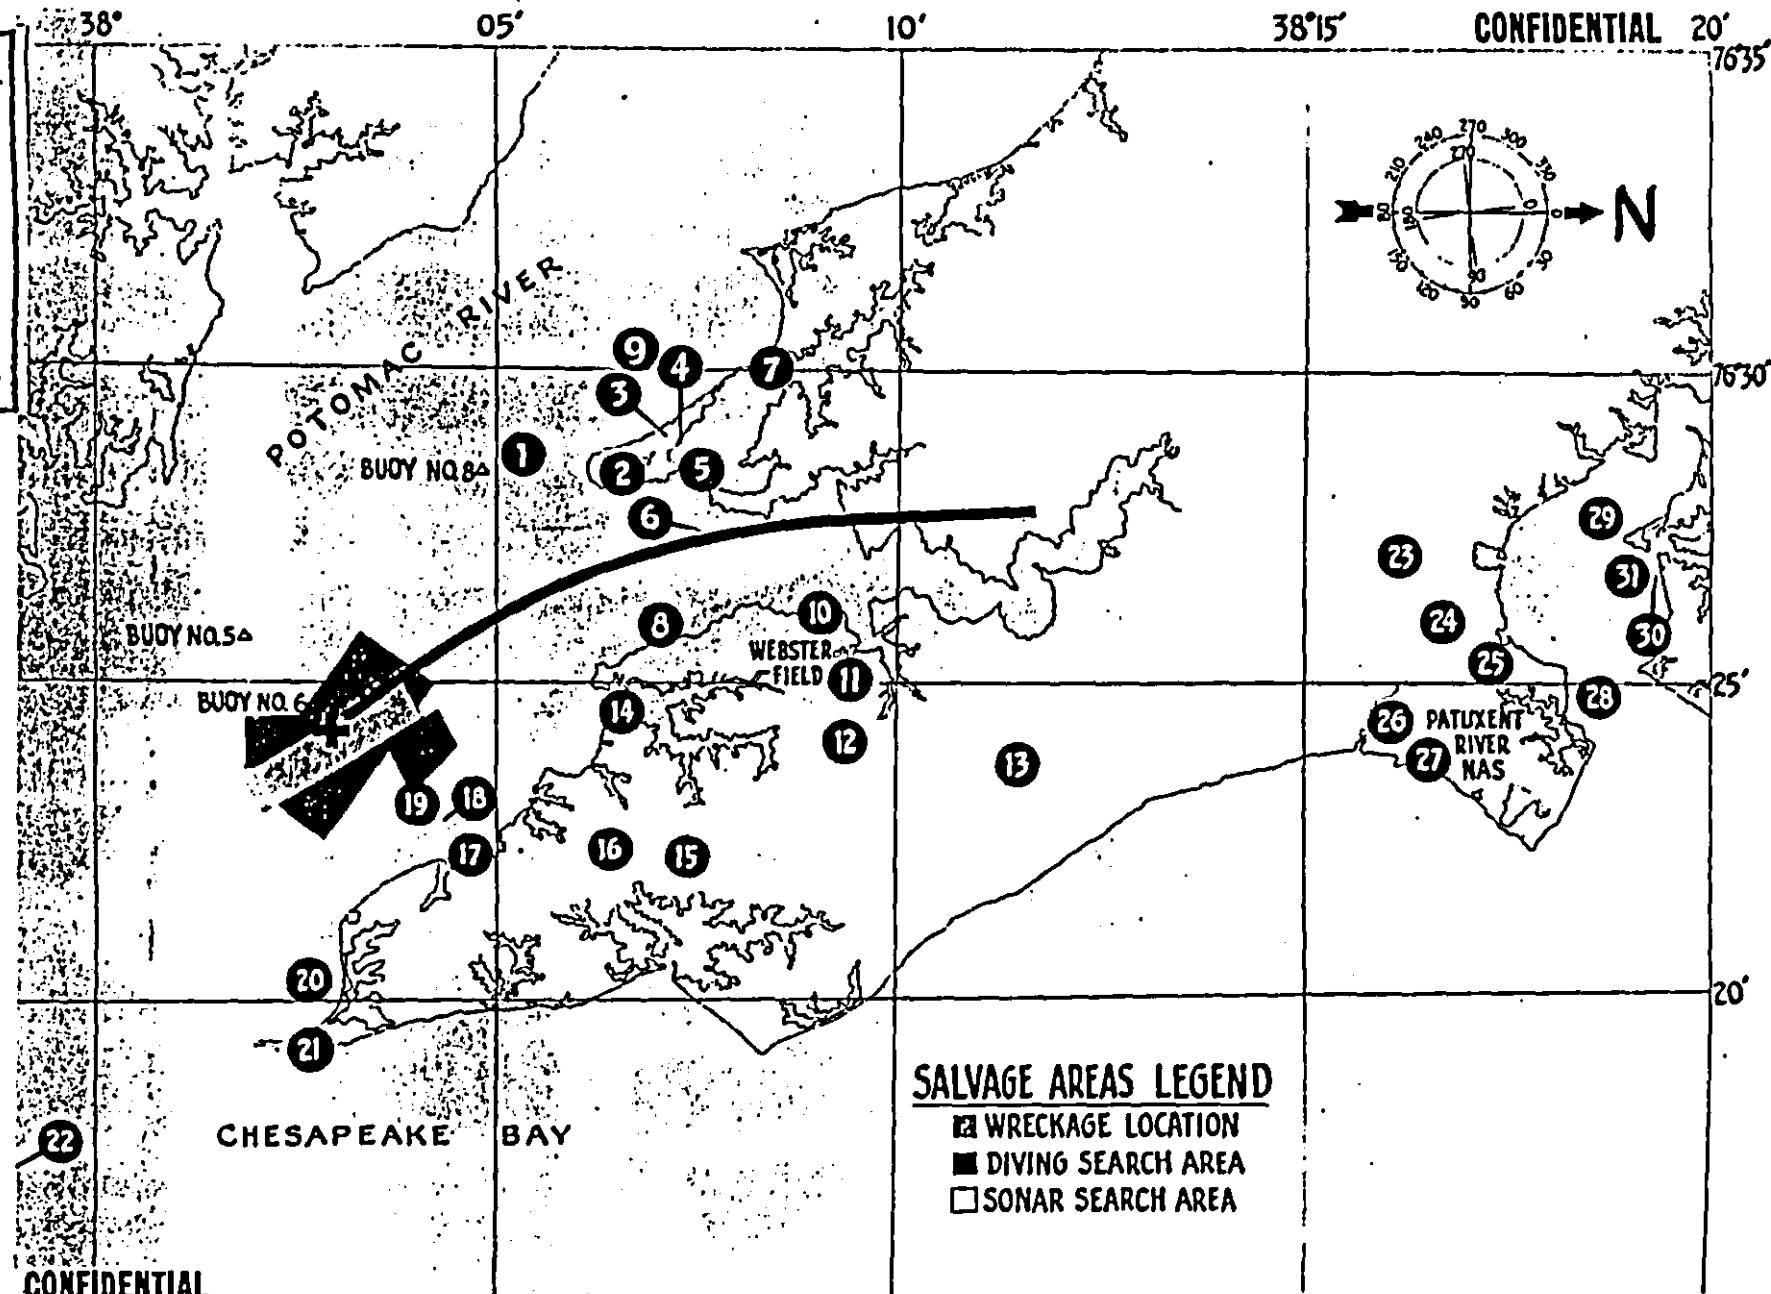
Fig. 2. Witness Locations and Salvage Operations

The United States Navy had a salvage fleet in operation almost continuously from December 7 to March 2 (Fig. 2). Considerable difficulty was experienced in obtaining wreckage because of the depth of water in the channel (40 to 70 feet) and the silty condition of the bottom. Sonar search, underwater television, and diving operations were successful in locating major pieces of wreckage. Extreme care was used in plotting the location of each piece so that a fall pattern could be constructed (Fig. 3). During the later period, dragging operations were used to recover smaller pieces. It is estimated that about 85 to 90 per cent of the structure and equipment was recovered.

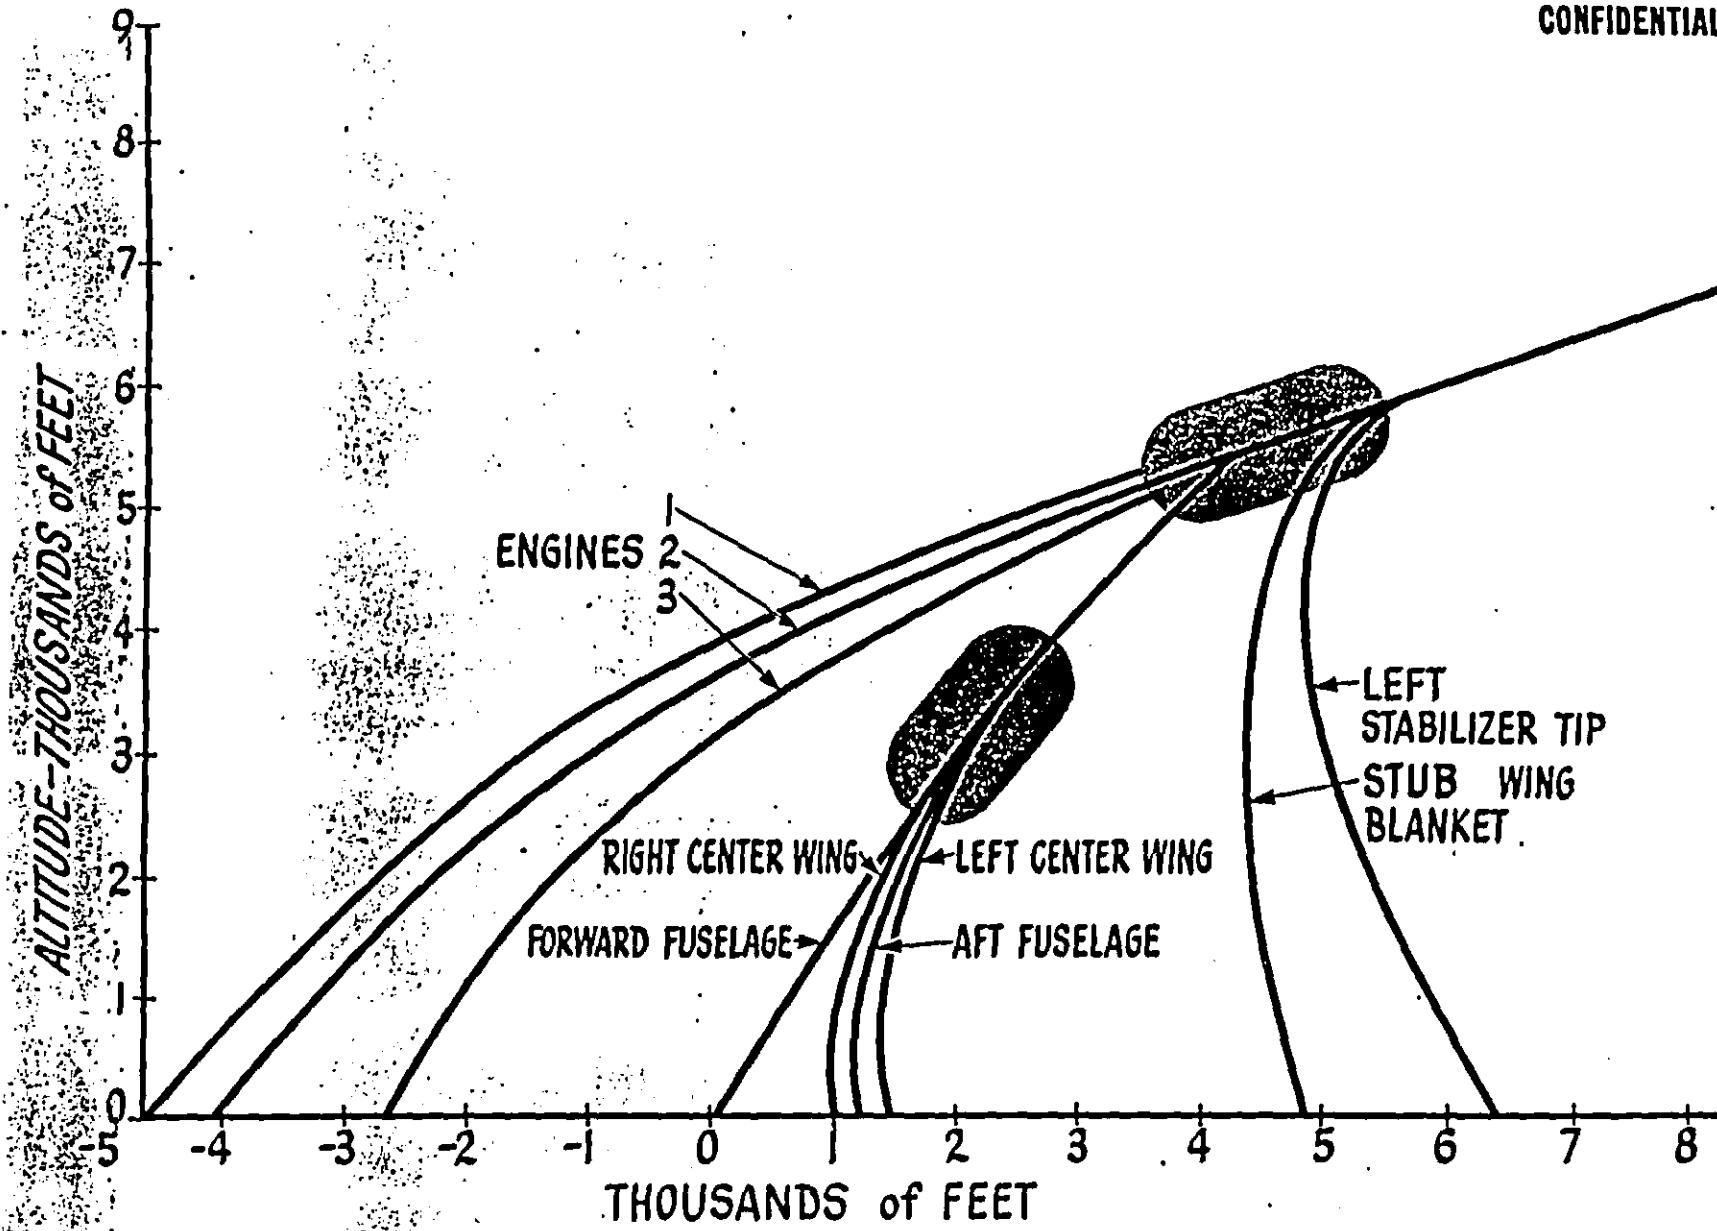
Fig. 4. Trajectory Pattern

By using the recovery locations of major pieces of wreckage, it was possible to compute fall trajectories and to obtain an approximate idea of the altitude and distance from the crash point where these items left the airplane (Fig. 4). Trajectory studies also establish a general flight path during the period of break-up and fall-out.

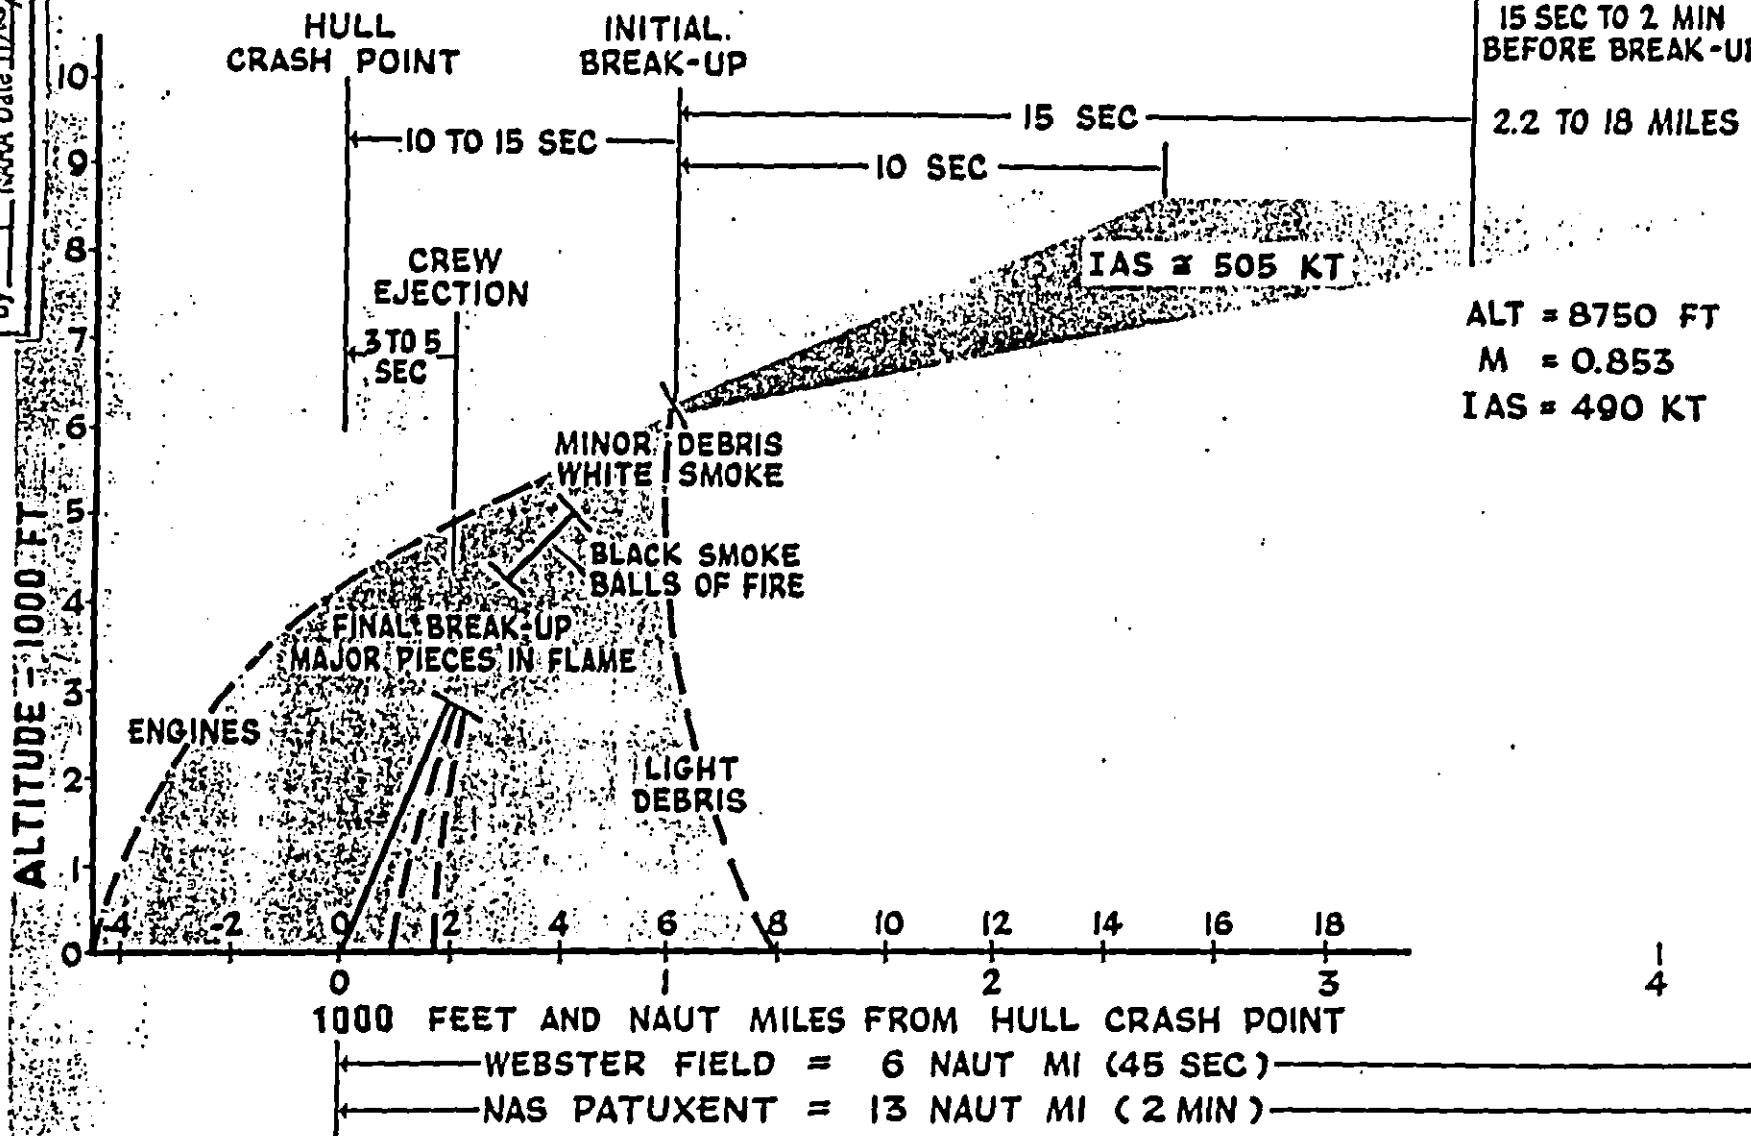
Fig. 6. Accident Envelope

In spite of the incompleteness of information, the basic factual data can be combined to form a flight profile which envelopes the general nature of the accident (Fig. 6). These basic facts and primary deductions have been useful in eliminating many types of initiating causes, and they have narrowed the field to a few possibilities which will be discussed in the technical summaries.

These are the conditions which must be satisfied by any theory of accident cause.

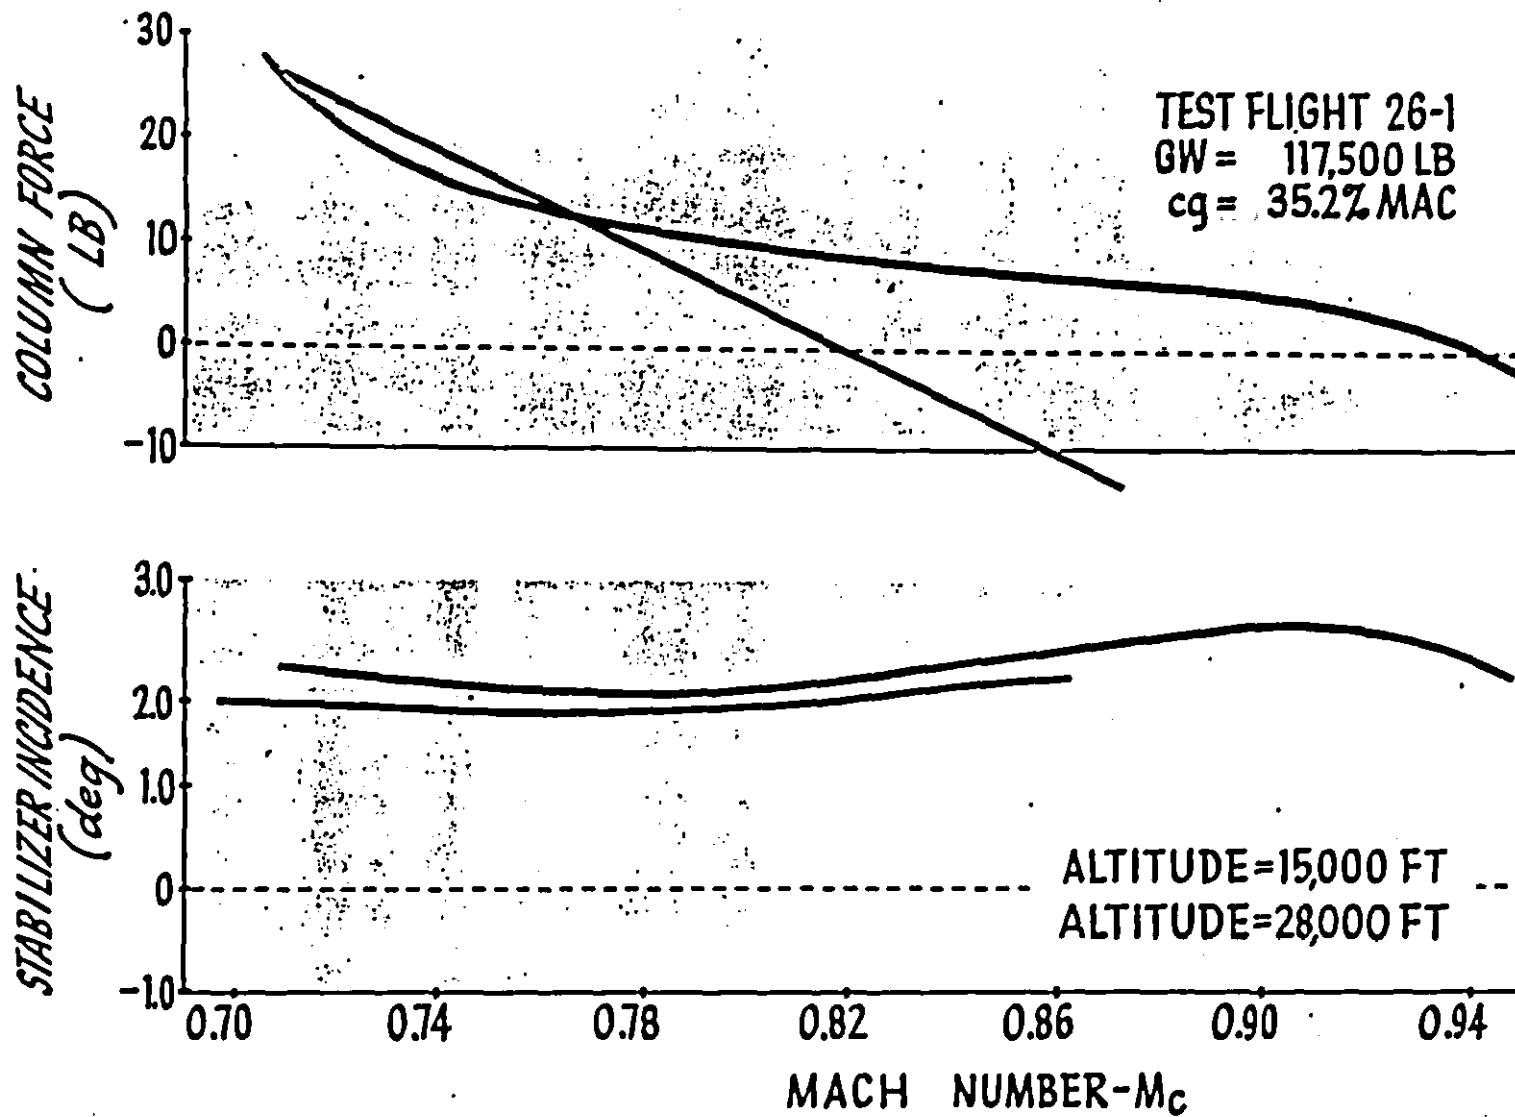
Fig. 8. Static Longitudinal Stability

The static longitudinal stability of the aircraft in level flight has been investigated at altitudes of 15,000 and 28,000 feet (Fig. 8). These runs were trimmed at Mach 0.81 and Mach 0.94. Although slightly unstable gradients of stabilizer position versus speed are indicated above Mach 0.76, stick forces were stable throughout the speed range for both tests. Since pilots fly almost exclusively by force feel in the high speed range, the aircraft is considered to possess satisfactory longitudinal stability characteristics in one-g flight. Pilots' comments have been quite favorable with regard to these flying qualities. The stable control force characteristics are due to the speed-feel compensation which has been incorporated in the synthetic feel system. Flight test results and the predictions from wind tunnel data compare very favorably.

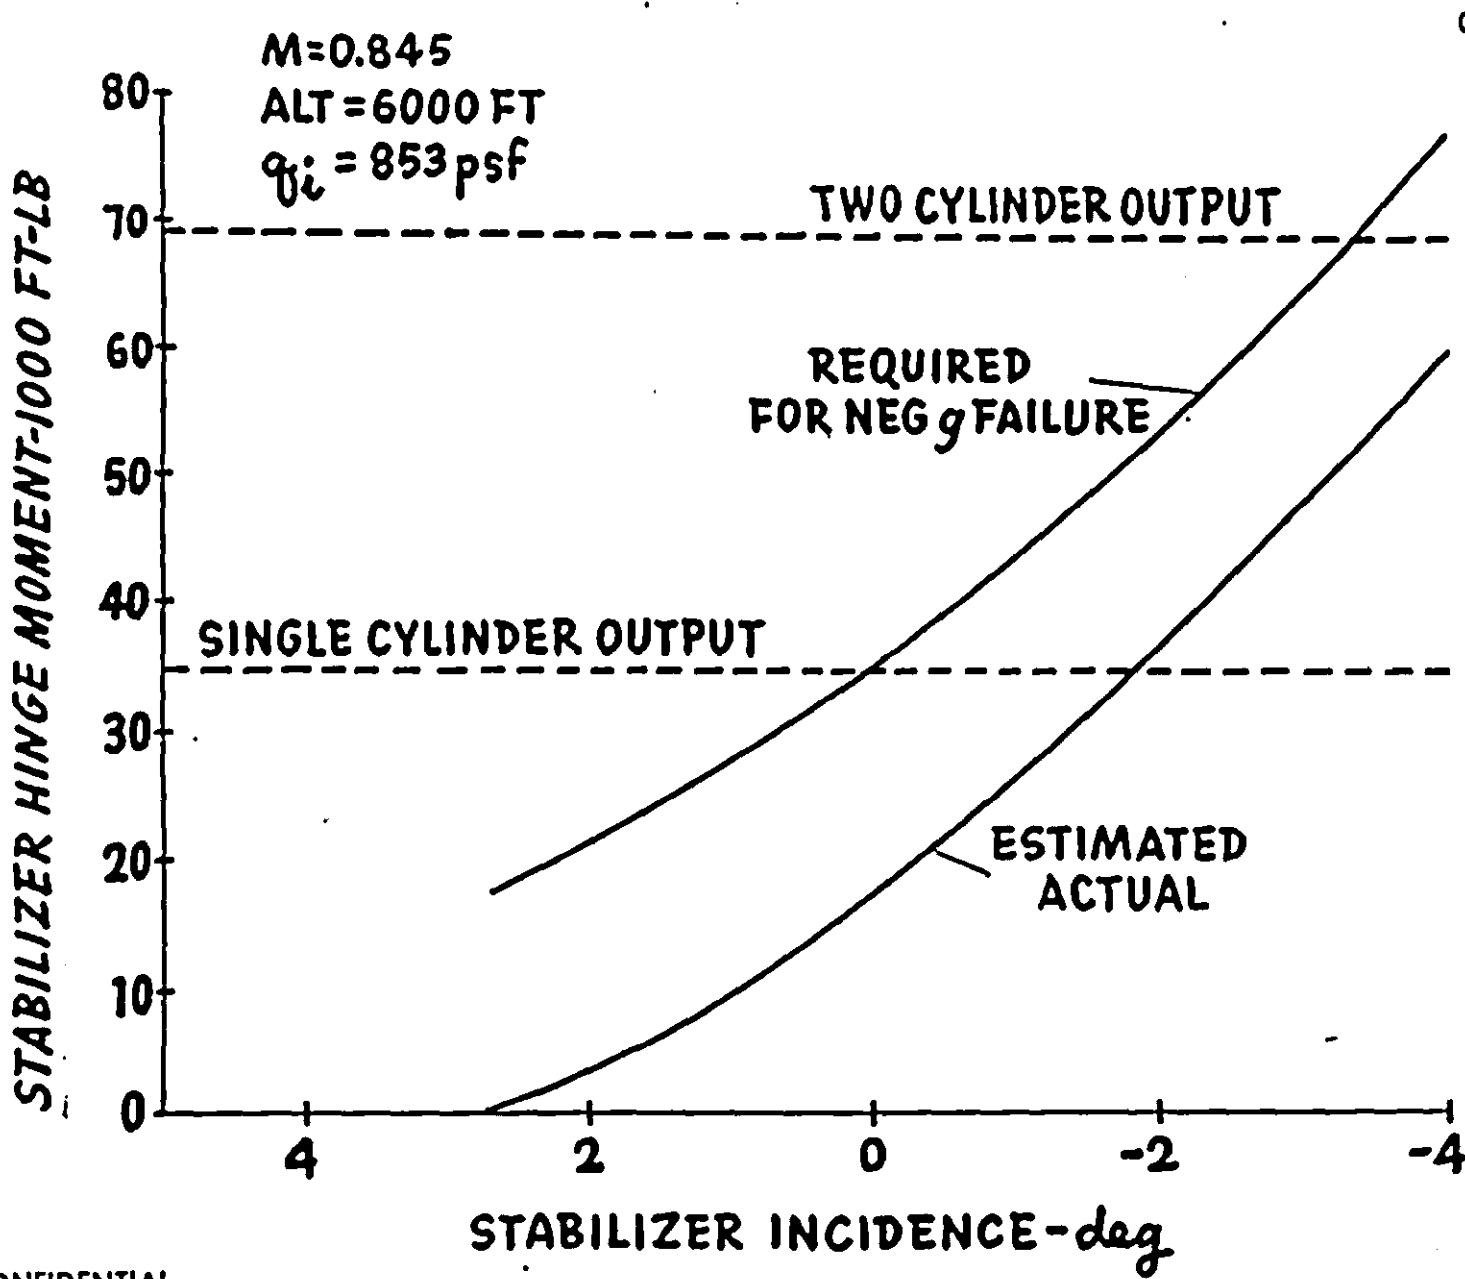
Fig. 9a. Stabilizer Hinge Moments for Negative-g Break-Up

Pertinent to the accident, the stabilizer hinge moment would have had to exceed 48,500 foot pounds in order to develop enough negative g's to fail the wings.(Fig. 9a). However, the stabilizer "q"-feel screw jack position indicates that the aircraft probably did not build up excessive speed. It may be theorized, therefore, that an overpowering of the stabilizer of small magnitude did not occur. In order for the severe overpowering of one cylinder to occur, the hinge moments would need to be at least 50 percent above the conservative estimates. This is not considered to be probable although mis-rigging of the elevator could contribute significant hinge moment changes. Unless there was a significant mis-rigging, it is unlikely that the loss of one hydraulic system was associated with the accident sequence.

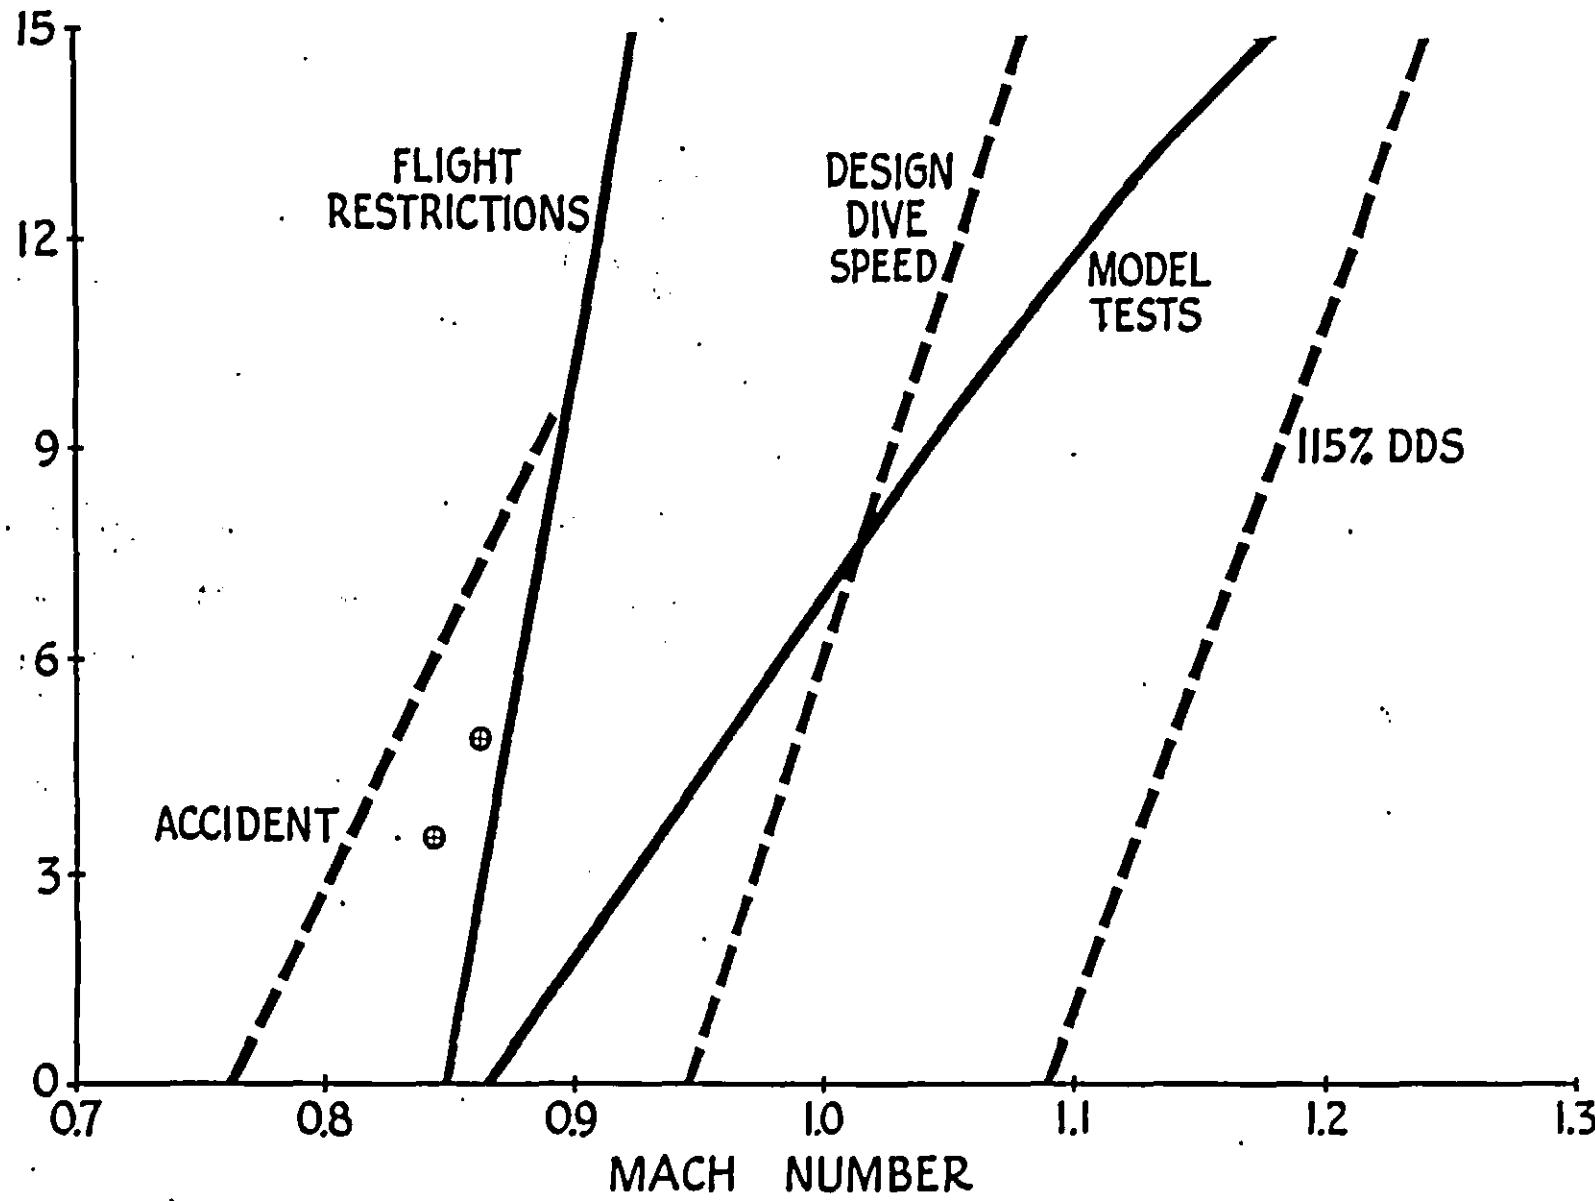
Fig. 18. Flutter Limits

Test flights were monitored by accelerometers fixed at various points on the aircraft. None of the records gave any indication that the airplane was in danger of flutter within its flight limitations (Fig. 18).

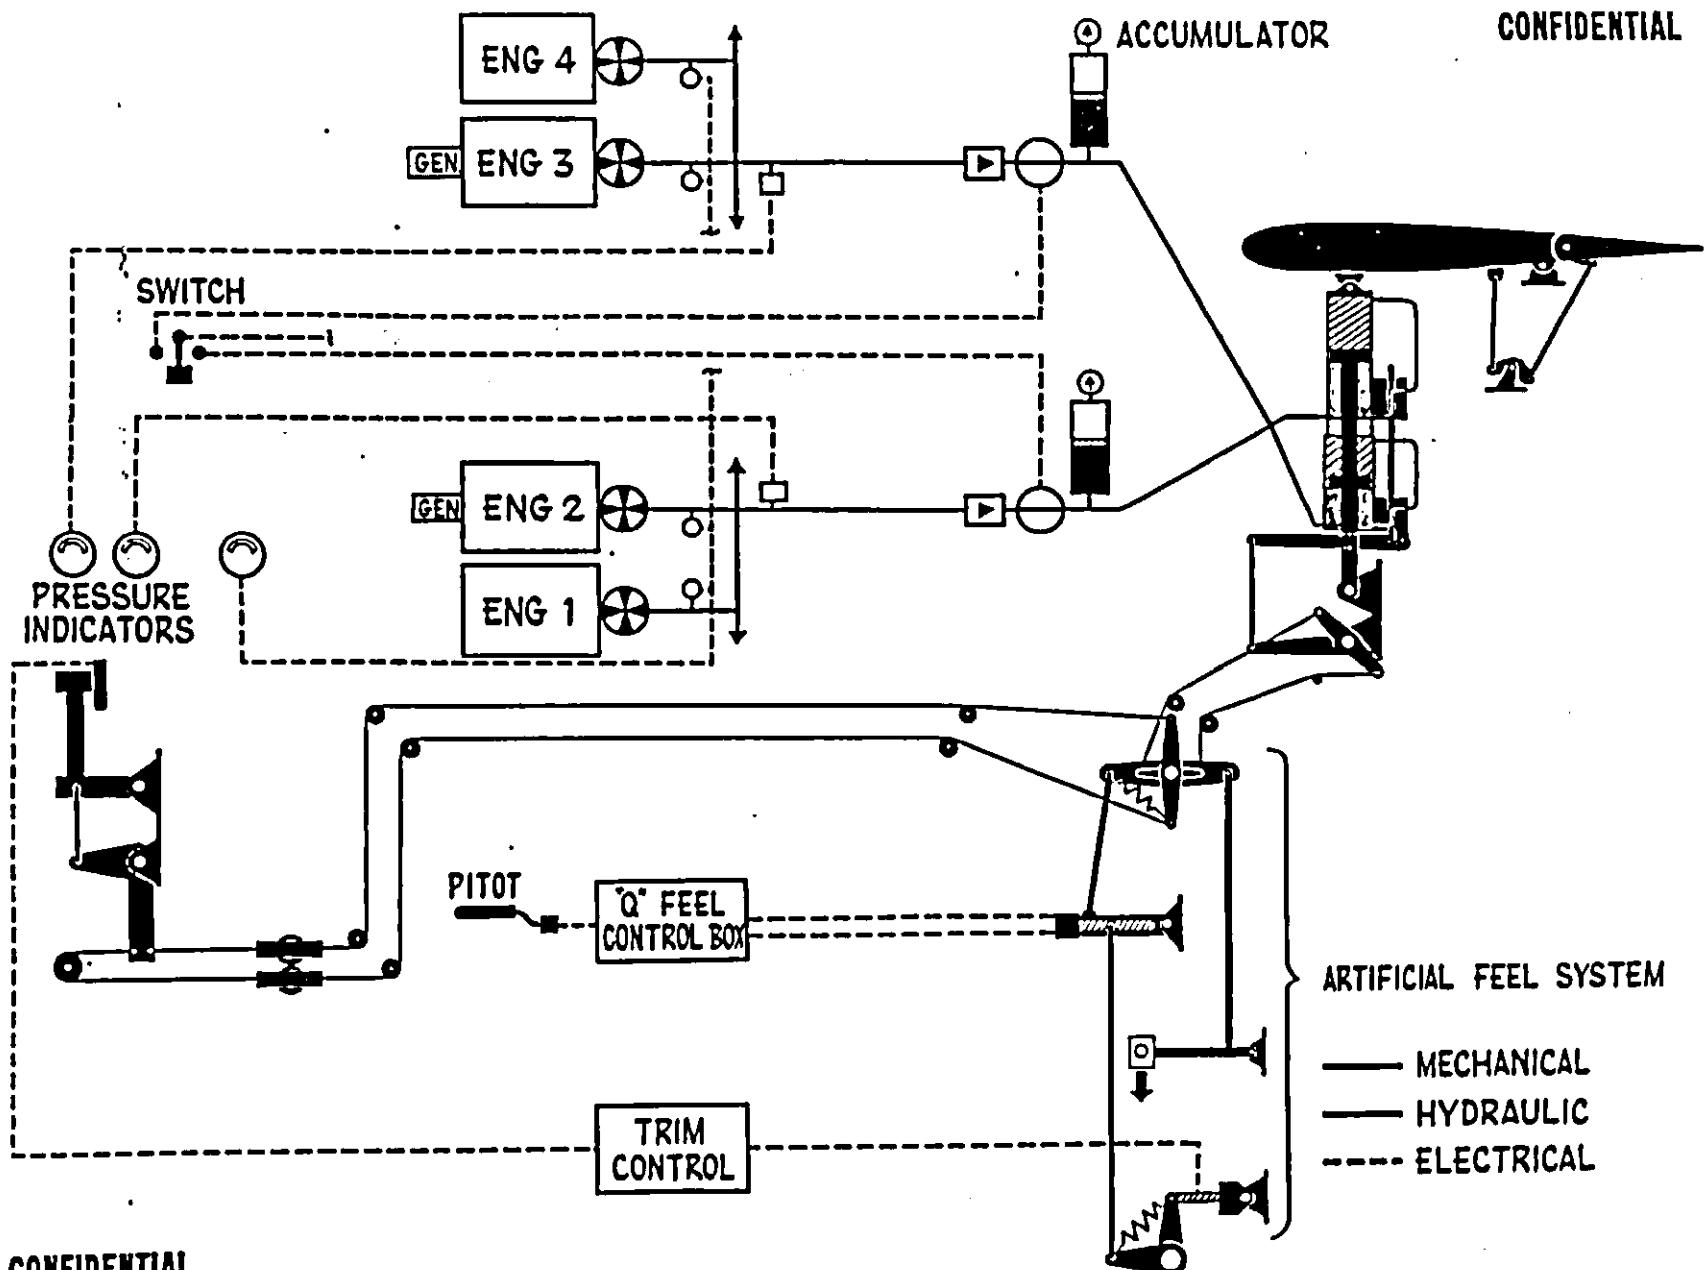
Fig. 20. Longitudinal Control System Schematic

Although all hydraulic and mechanical control systems have been investigated, the nature of the accident -- violent nose-down pitching of the airplane with little or no roll or yaw -- indicates that major effort should be devoted to an analysis of the pitch control system (Fig. 20).

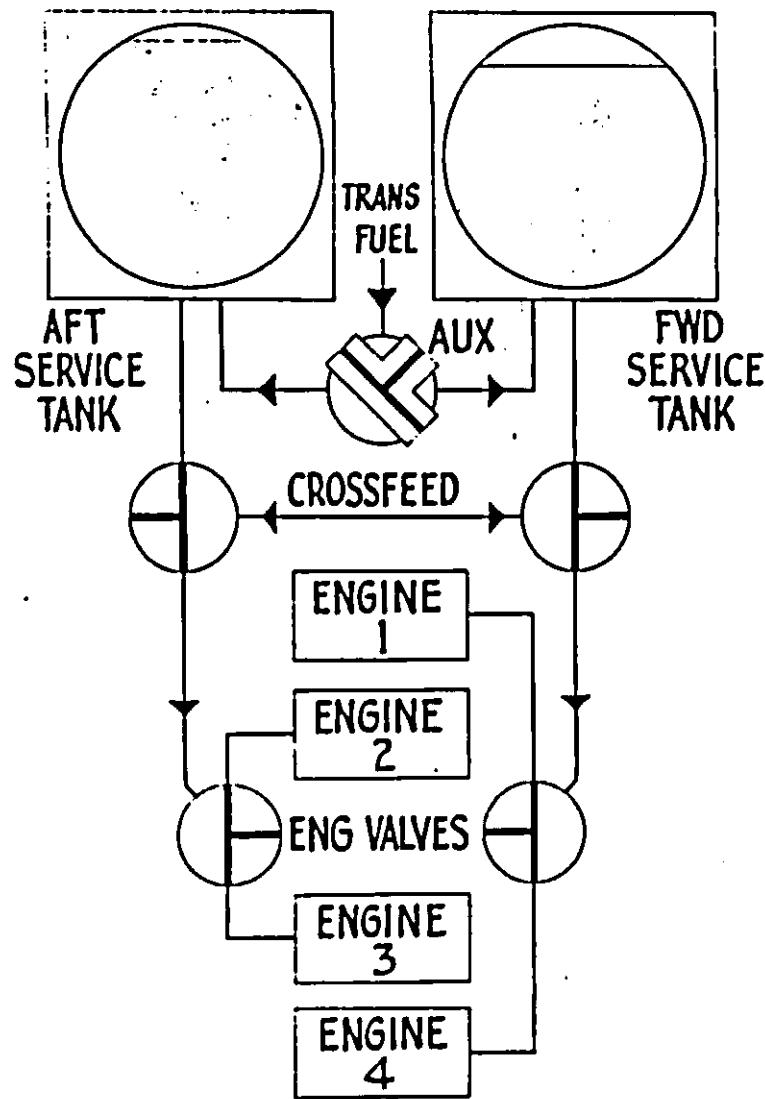
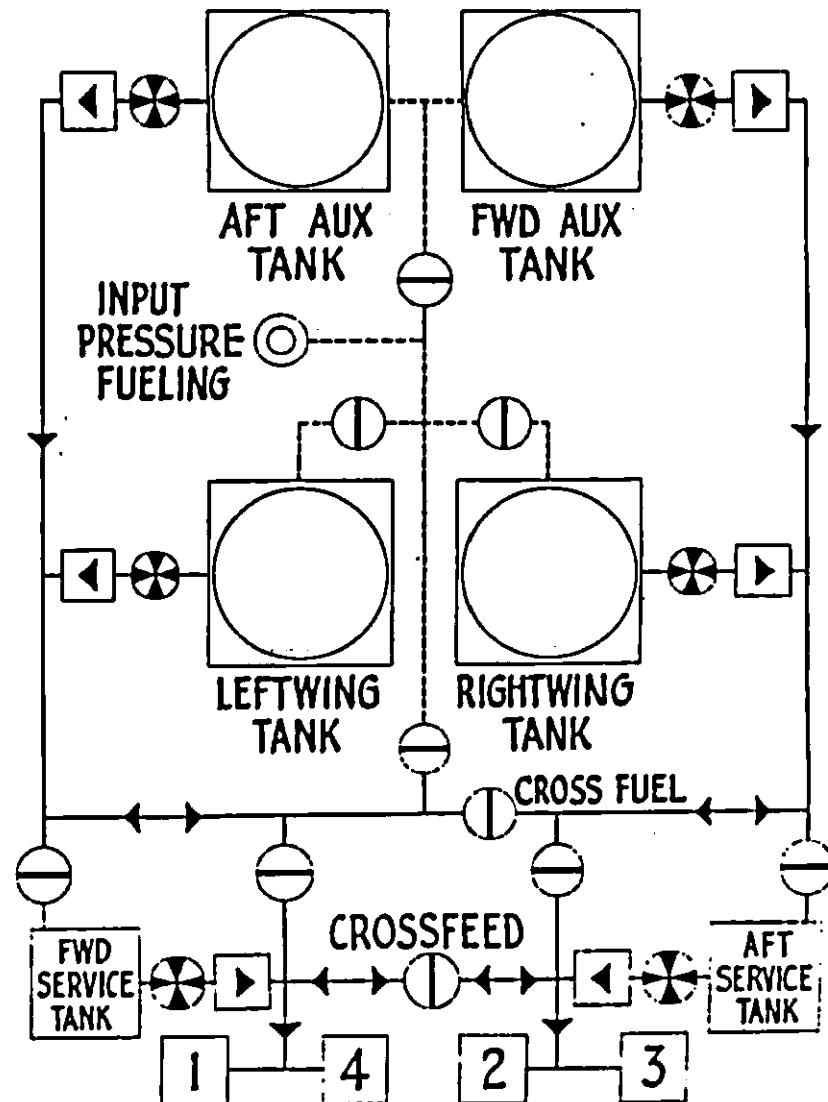
Fig. 22. Fuel Control Panels

Management of the fuel system is accomplished through two visual-flow fuel control panels: one accessible to the pilot and copilot in the cockpit, and an auxiliary panel accessible to the flight engineer at the radio operator's station (Fig. 22). In normal management the two outboard Engines 1 and 4 are fed from the forward service tank, and the two inboard Engines 2 and 3 are fed from the aft service tank. Control of fuel feed to the engines is possible only from the pilot's panel, but he can delegate to the auxiliary panel the transfer of auxiliary fuel to the service tanks.

- 1) Increase the size of the fuel transfer lines from the wing tanks (Rib 56) to the service tanks to reduce the time required to refill service tanks after use of the afterburners.
- 2) Identify all fuel systems control valves with readily visible decals to facilitate manual operation in the event of 28-volt electrical failure.
- 3) Relocate the pressure fueling unit aft of the airlock to eliminate possible fuel or vapor leaks in the airlock compartment.

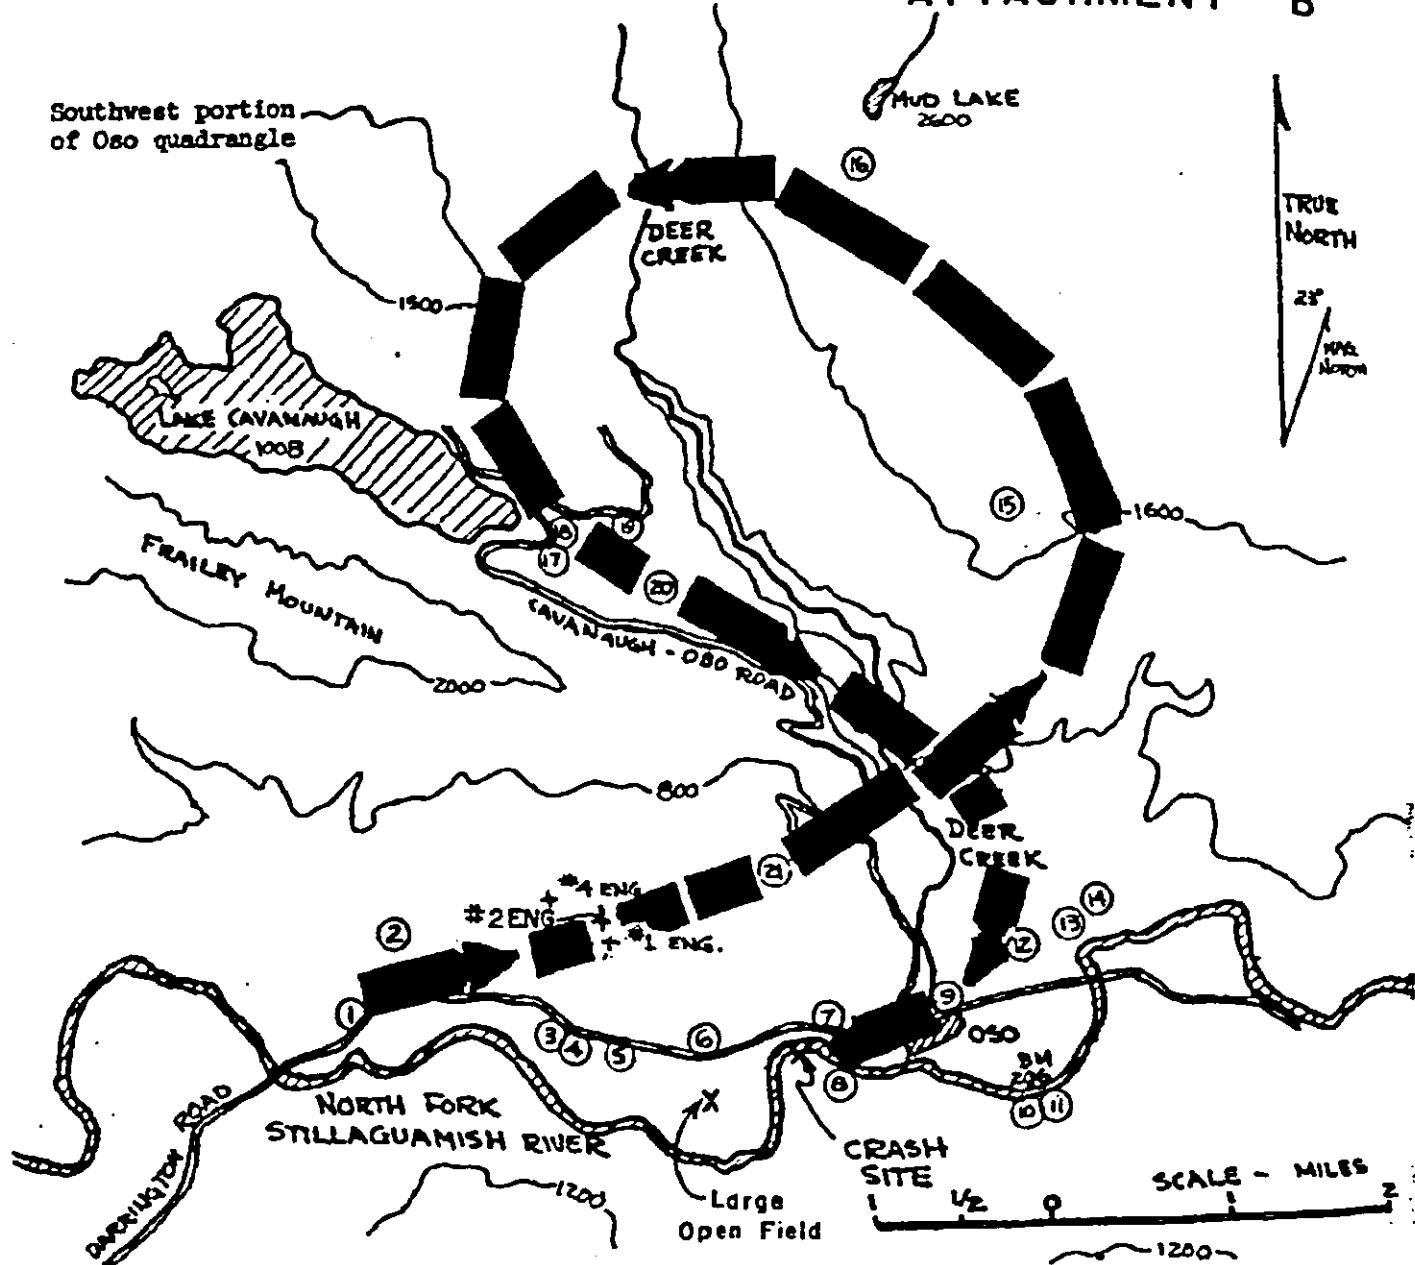
ATTACHMENT "B"

CIRCLED NUMBERS INDICATE
LOCATION OF EYE WITNESSES.

Accident involving Aircraft N 7071
occurred one mile west of Oso,
Washington, on October 19, 1959
