## Additional Emergency Exit for Flight Tests

Paulo Quattrocchi EMBRAER Flight Test FTSW, Seattle, 05.02.2012

This presentation covers historical events, the last 20 years learning results on additional emergency exits for EMBRAER flight test prototypes, submitted to a civil certification process (ANAC, FAA, EASA), and the latest features added to the Legacy 500 (001 and 002 prototypes), with its test results.

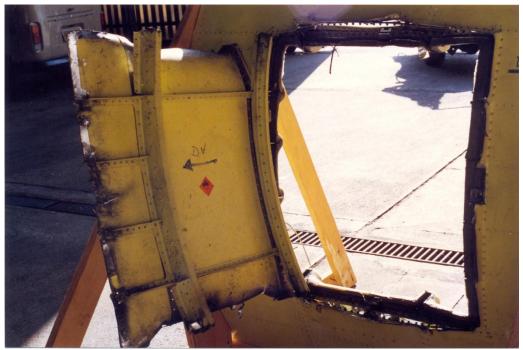
#### **ERJ-145: Explosive windows**

• The exit was through the cockpit windows and a blown up hole on the right side of the fuselage.

• The escape sequency was:

Push trigger, jump out.

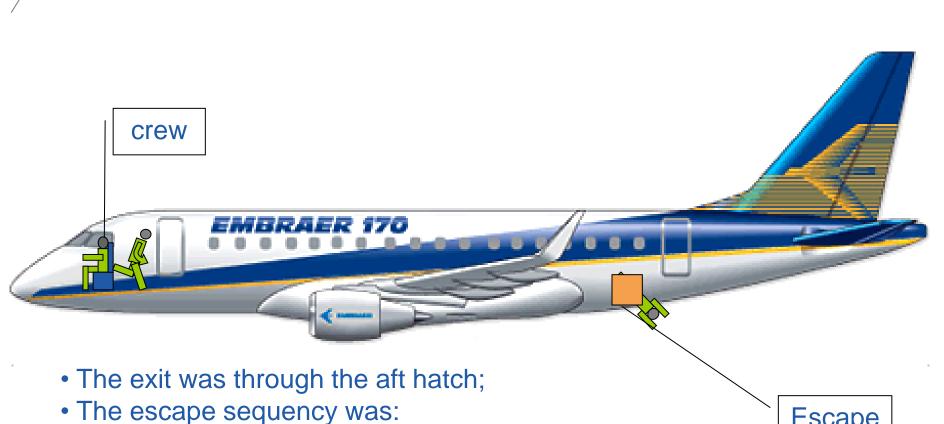
#### E-170: "Potty" hole

depressurize acft., run all the way to the back, blow the door, jump through hole Escape Hatch

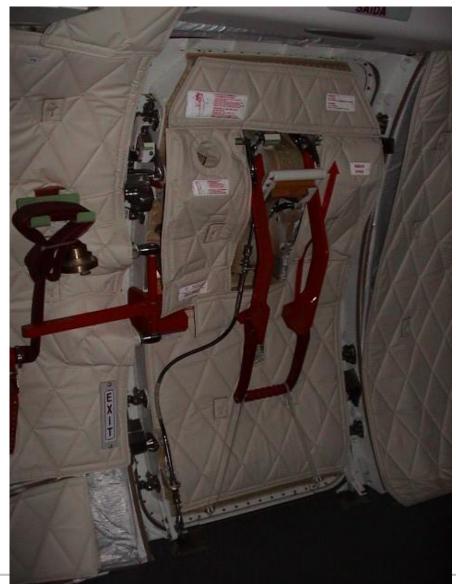
#### E-175, E-195

# "Fast" opening door for pressurized situations.
